Description: Tail light
Part Number: 311048-311092
Application: 2007-2008 Toyota Tundra

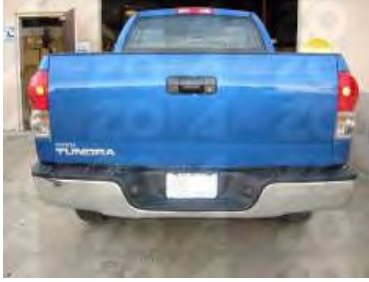
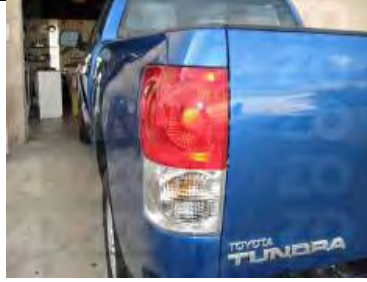
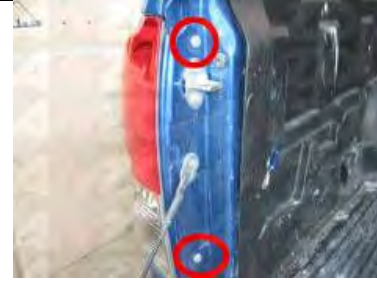
Tools needed: T27 Torque bit
socket.

Step 1: Use the t27 torque bit
socket to remove the two
screws holding in the tail light.

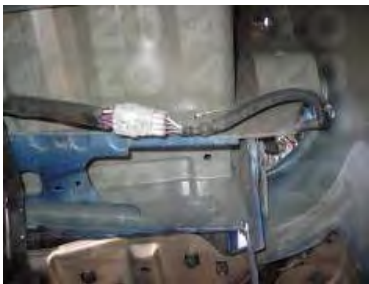
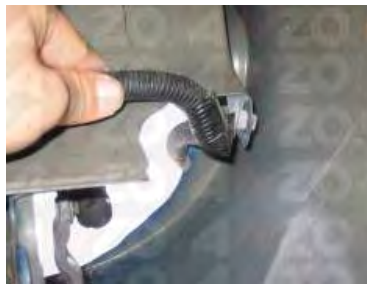
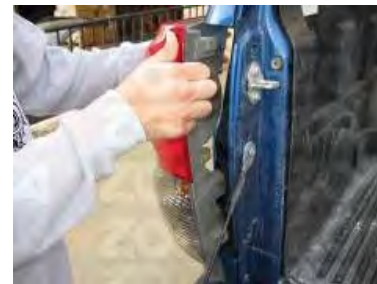
Step 2: Under the vehicle bed
unplug the wire harness.

Step 3: Unclip the wire
harness from the frame.

Step 4: Take the tail light off
from the vehicle.

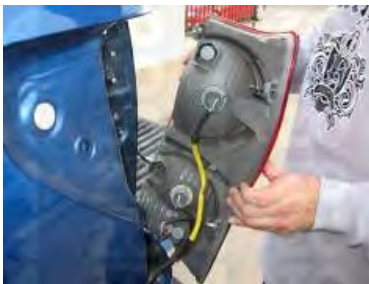
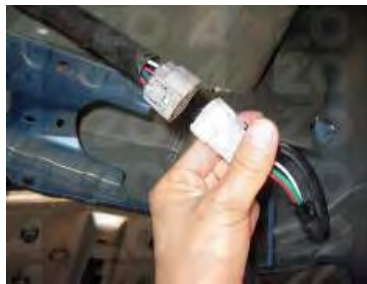
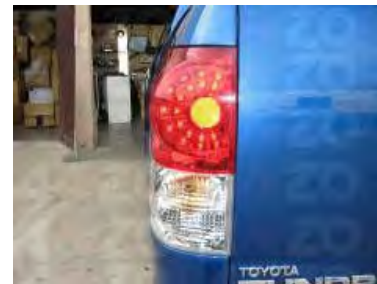
Step 5: Put in the new Anzo
led tail light into the vehicle.

Step 6: Plug in the new Anzo
wire harness into the original
socket of the vehicle.

Step 7: Test all functions
making sure they work
properly before driving.
