INSTALLATION INSTRUCTIONS
SIDE BAR PART#204003/204003-2

2000-10 CHEVY TAHOE (supercedes 204010) 2007-10 YUKON

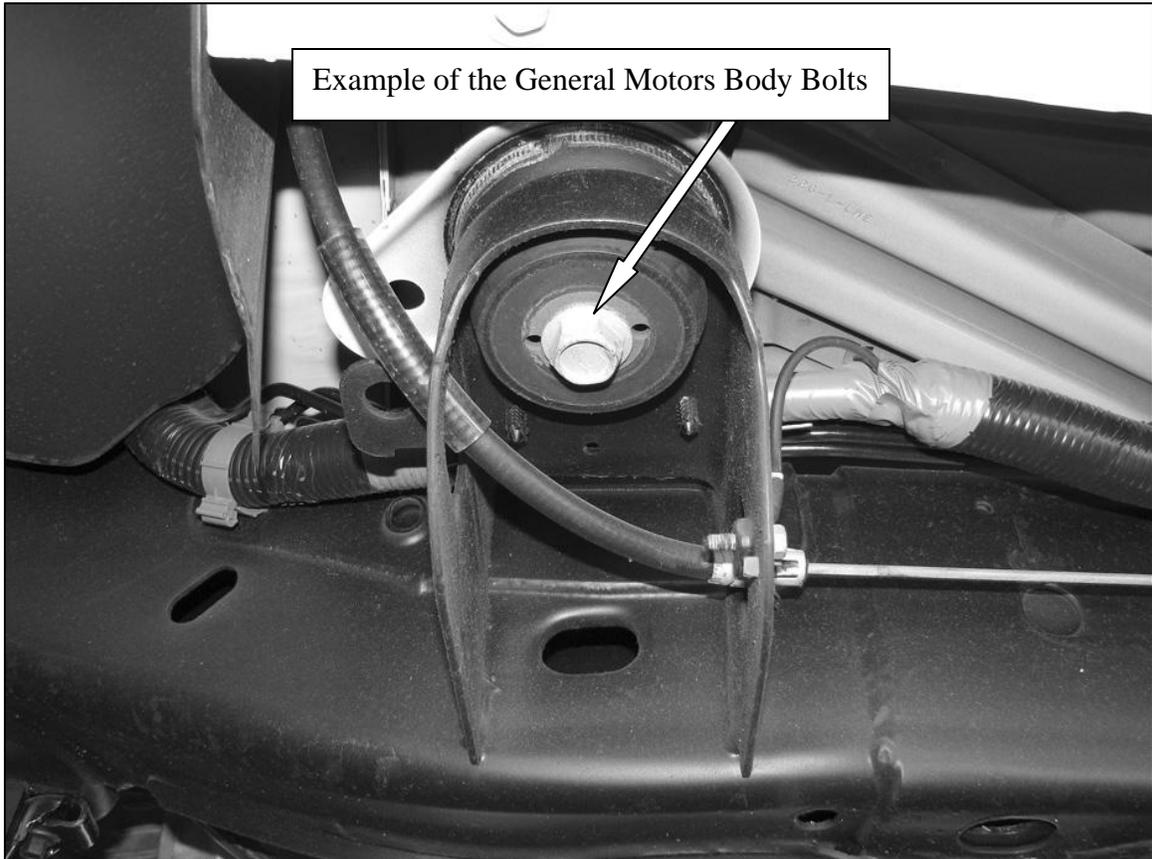
Currently, all Side Bars manufactured for GM trucks use the factory body mount bolts to attach the bars and brackets to the truck. In years past, GM used a fixed nut that was welded in place to the chassis of the truck. Starting late 2010, GM has now gone to a loose nut that is surrounded by a "Cage Nut" which has two tabs on either side of the nut to keep it from loosening. Along with this cage nut, GM is also using Heavy Duty Loc-tite on the Body Mount Bolts for added protection.

Due to this change, Aries is recommending **EXTREME CARE** when removing the factory body mount bolts from these trucks. **Loosen and re-tighten all body mount bolts by hand! DO NOT use Impact Tools of any kind!** If bolts become increasingly tight as you are loosening them you may need to retighten & loosen the bolt several times to clear the loc-tite from the threads Failure to follow this instruction could cause the body mount bolts to seize and the tabs of the 'Cage Nut' to bend allowing the nut to spin freely inside Chassis floor board!
