## **68 RFE VALVE BODY UPGRADE**

<b>Part #:</b>	<b>1030360</b>	<b>2007-11 (Early Model)</b>
<b>Part #:</b>	<b>1030361</b>	<b>2010-12 (Late Model)</b>

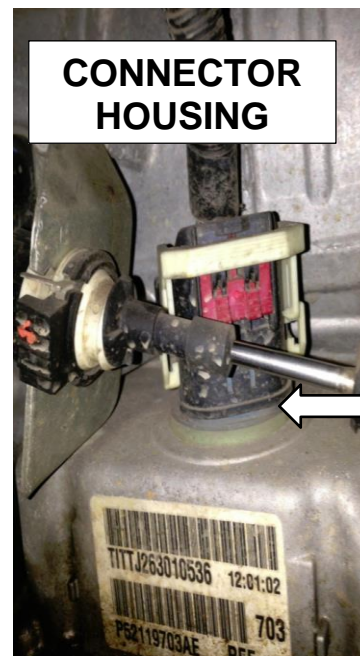
The transmission main electrical connector is located on the driver's side of the transmission. The color of the connector protruding from the transmission will be white or grey and will determine the application.

White Connector = Early Model  
(Plate 1600186)

Grey Connector = Late Model  
(Plate 1600187)

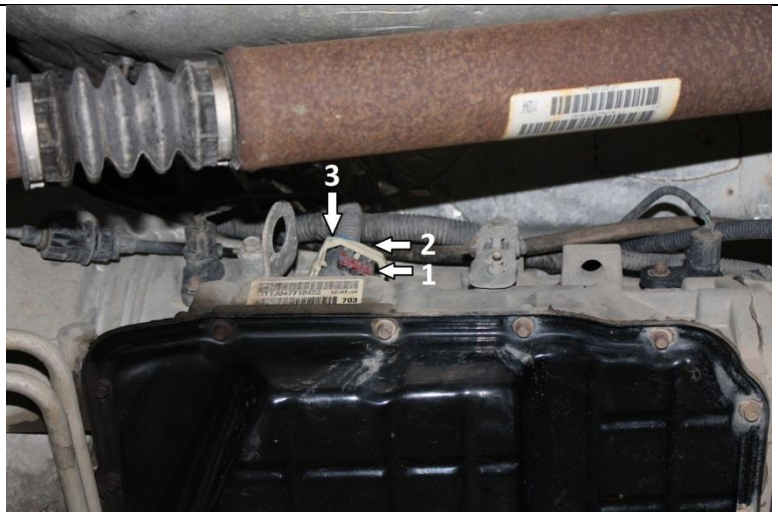
5. To remove connector, push red tab (1) downwards. Then, press the black tab (2) which will allow the white handle (3) to be rotated downwards, releasing the connector from the transmission.

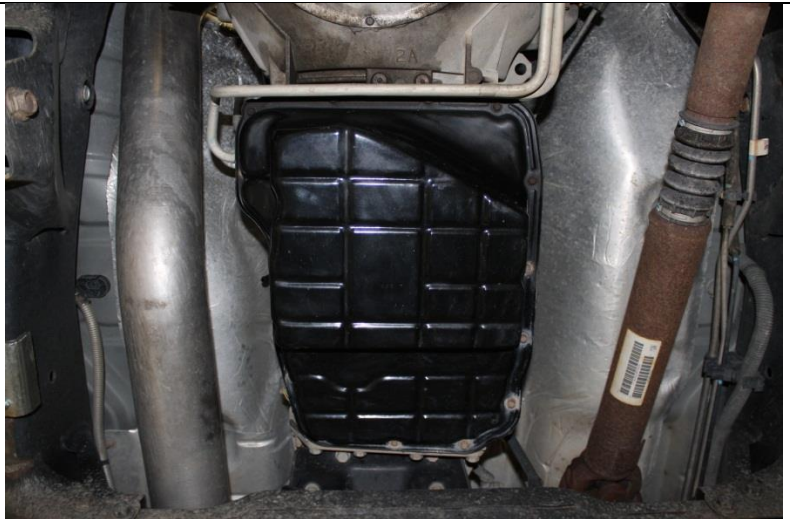
7. Remove 14 of the 15 transmission pan bolts (8mm). Loosen the remaining bolt but leave in place to keep the pan from falling. The transmission cooler lines may need to be moved to access some of the bolts, gently pry them out of the way.

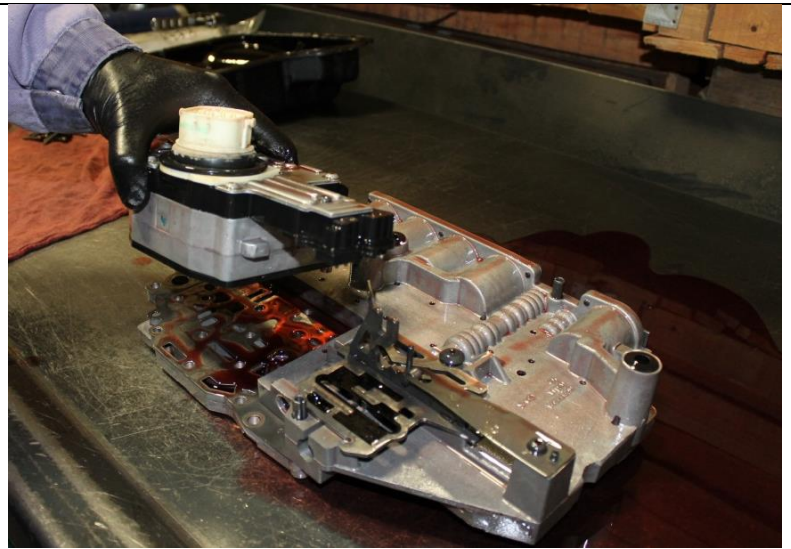
12. Remove fifteen T25 Torx screws securing the solenoid pack to the valve body, remove solenoid pack and place it to the side.

Note: All bolts are the same length.

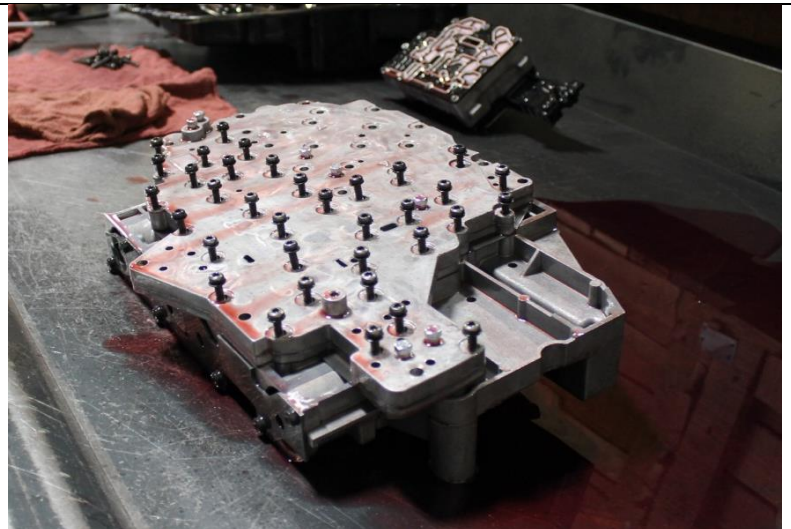
13. Remove remaining thirty five T25 Torx screws securing the valve body halves.

Note: All bolts are the same length.

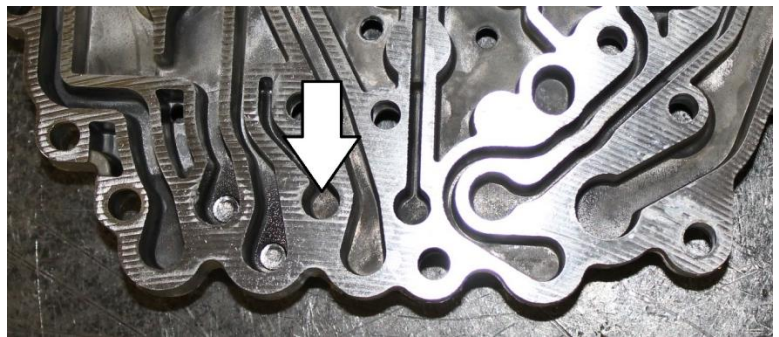
16. Thoroughly clean the bottom (smaller) half of the valve body. Locate the passage to be drilled.

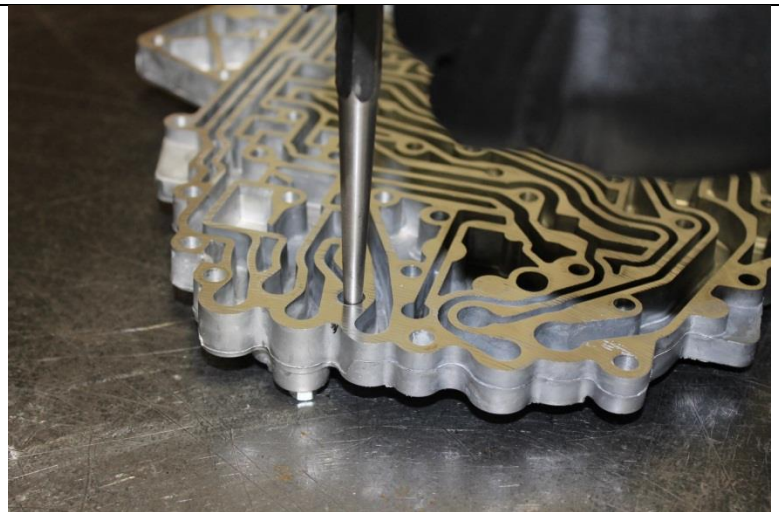
17. Punch center of hole using a center punch.

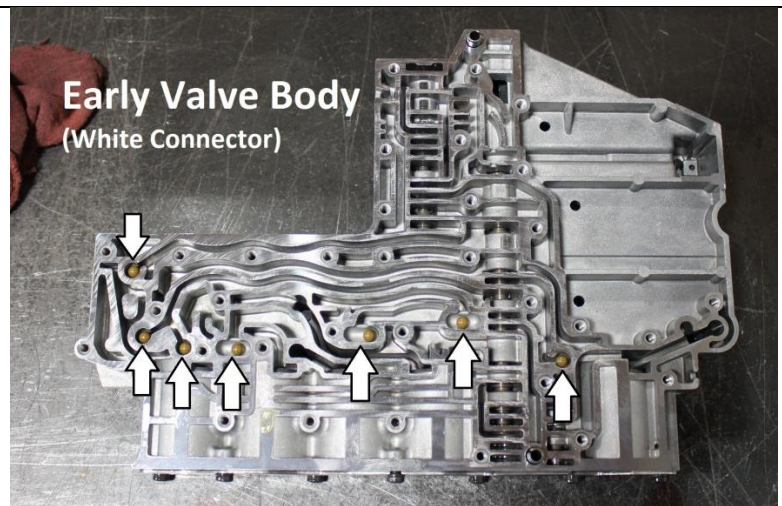
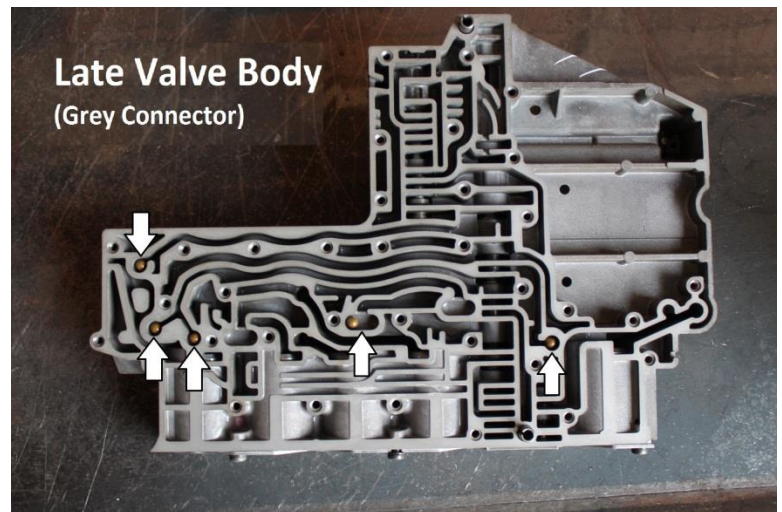
20. Ensure that all the check balls are still in the correct locations in the upper half of the valve body. Early model valve bodies (identified by white electrical connector on solenoid pack) have seven balls. Late models (gray connector) only have five.

*If this part has been contaminated in any way, it must be thoroughly cleaned before reassembly.*

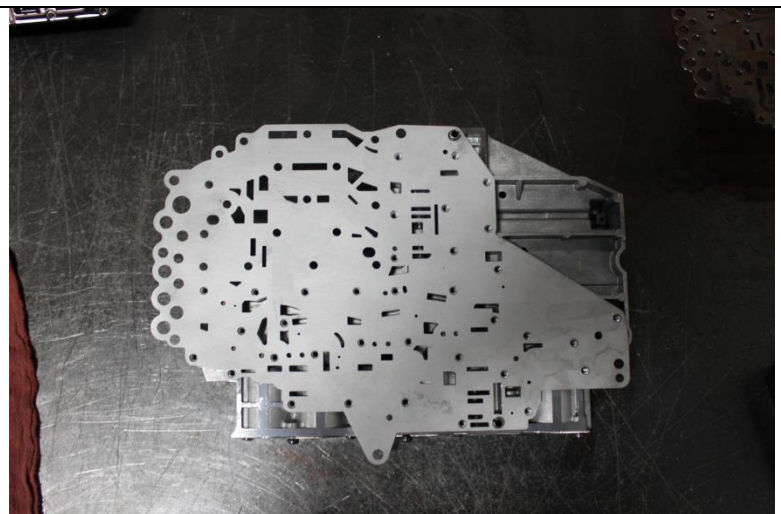
21. Install BD separator plate. Ensure it fits flat on the valve body.

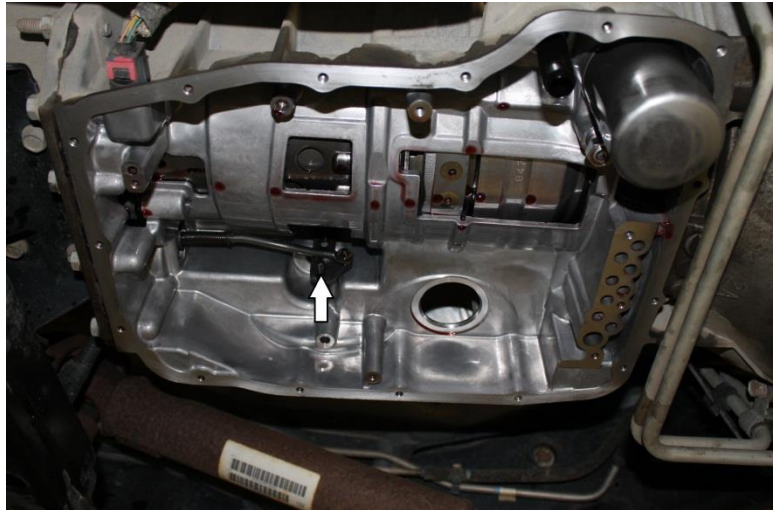
27. Check that the shift lever on the valve body lines up with the shift lever on the transmission and lift the valve body back into the transmission. Start the 8mm screws by hand, do not tighten yet. Work the shift lever on the outside of the transmission case by hand to ensure that the lever is making contact with the valve body correctly.
