INSTALLATION INSTRUCTIONS FOR PART 95-7417

INFINITI 1996-1999 I-30
MERCURY 1993-2002 Villager
NISSAN 1995-1998 200SX/240SX
1998-2001 Altima / 1998-2004 Frontier
1995-2003 Maxima / 1996-2004 Pathfinder/QX4 1997-2000
1993-2003 Quest / 1995-1999 Sentra
2000-2004 Xterra

95-7417

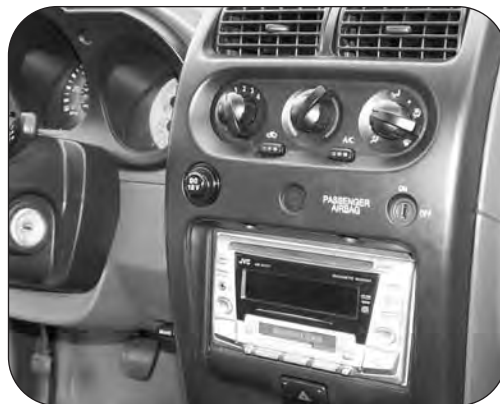
A) DDIN Trim plate B) DDIN Brackets

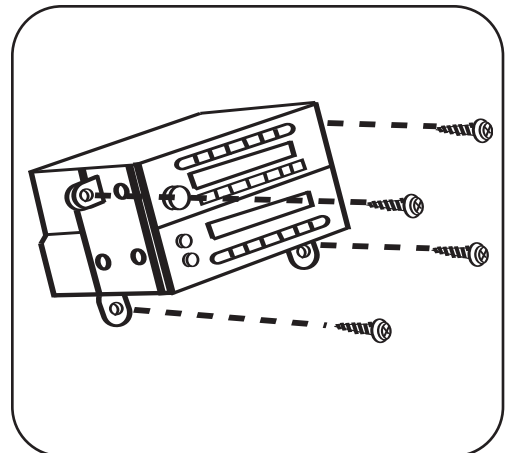
2001-2003 NISSAN PATHFINDER

- 1 Disconnect the negative battery terminal to prevent an accidental short circuit.
- 2 Unclip and remove the vent/clock assembly. (Figure A)
- 3 Remove (2) Phillips screws from the top of the radio trim panel then remove the panel. (Figure B)
- 4 Remove (4) Phillips screws securing radio. (Figure C)
