INSTALLATION INSTRUCTIONS FOR PART 99-2003

GM/SUZUKI MULTI KIT

99-2003

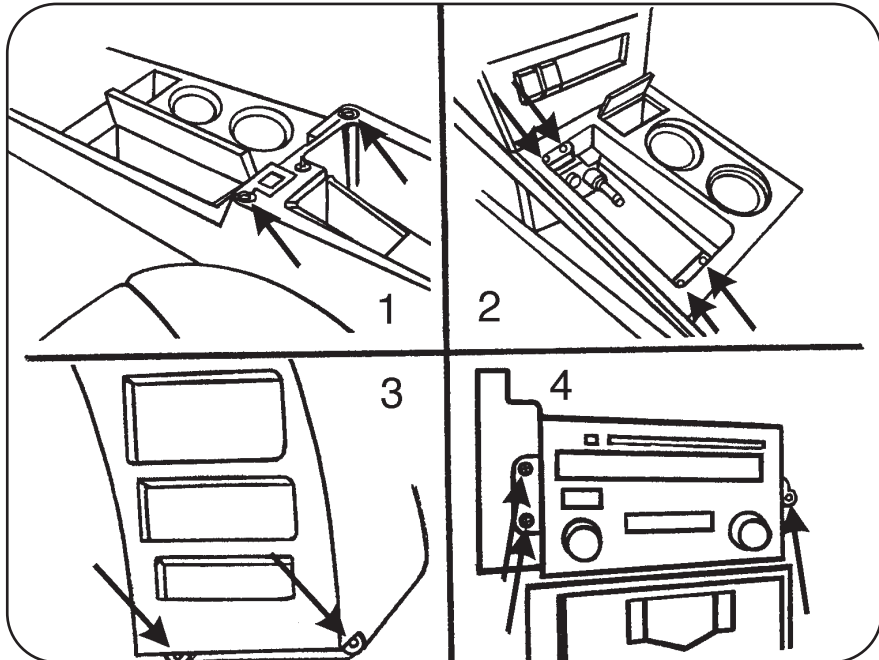
BUICK • Rendezvous 2002-2005

1. Open center console and remove (2) Torx T-15 screws at front of console opening.
2. Remove liners from cup holders and storage pocket next to cup holders, then remove (4) Torx T-15 screws. Unsnap and remove panel.
3. Remove (2) 7mm hex head screws from bottom of driver side dash panel and remove.
4. Unclip dash panel and remove.
5. Remove (3) 9/32" hex head screws to remove radio.
6. See page 44 for all vehicle tab instructions.

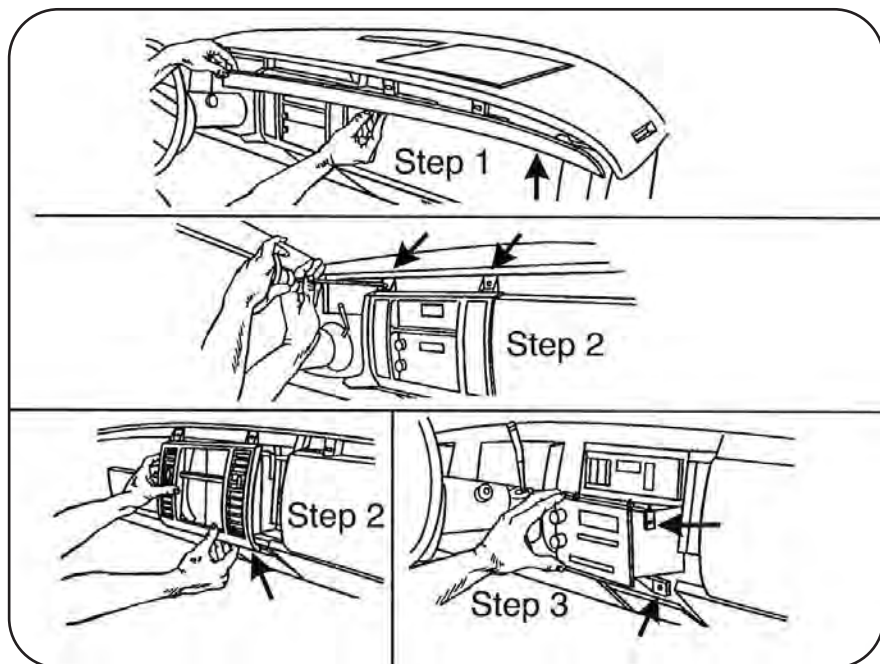
**CADILLAC • Fleetwood 1990-1996 /
Fleetwood Brougham 1990-1996**

1. Carefully unsnap trim panel above a/c controls.
2. Remove (2) 7mm screws at the top of the radio/air conditioning bezel, then unclip panel and remove.
3. Remove (4) 7mm screws that hold the radio in, slide radio out, unplug the radio harnesses and remove radio.
4. See page 44 for all vehicle tab instructions.

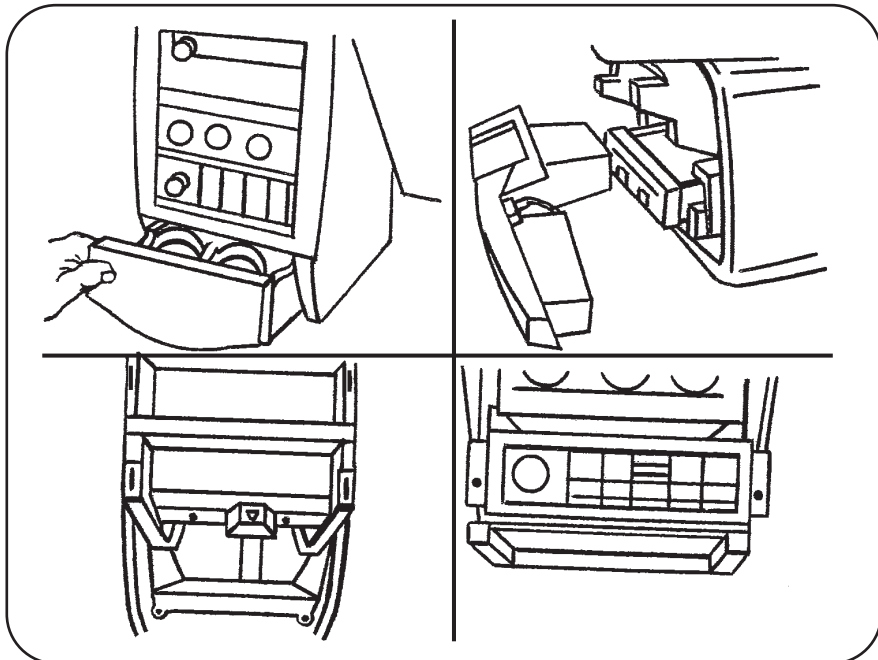
CHEVROLET • Venture 2001-2004
OLDSMOBILE • Silhouette 2001-2004
PONTIAC • Montana 2001-2004

1. Open cup holders and remove (2) Phillips 7mm screws.
2. Unsnap and remove dual power outlet assembly from lower storage.
3. Open lower storage door and remove (2) 7mm screws inside.
4. Models with DVD - Remove DVD player and remove (2) 7 mm screws from behind and (2) 7 mm screws near the floor.
5. Remove lower storage compartment .
6. Remove (2) 7mm screws (facing up) from under cup holder.
7. Remove (3) 7mm hex-head screws and remove radio.
8. See page 44 for all vehicle tab instructions.
