## INSTALLATION INSTRUCTIONS FOR PART 99-2009

# APPLICATIONS GM/SUZUKI MULTI KIT

## 99-2009

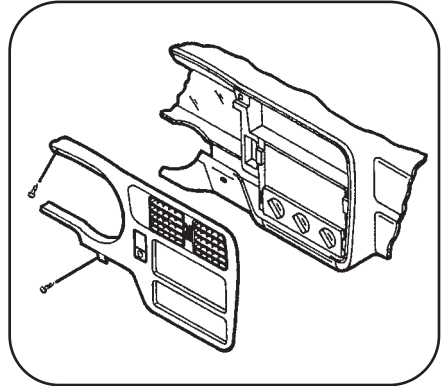
**CHEVROLET • BLAZER 2002-2005  
5-10 2002-2004 (WITH DOUBLE DIN RADIO)  
GMC • SONOMA 2002-2004  
OLDSMOBILE • BRAVADA 1998-2001**

- 1** Disconnect the negative battery terminal to prevent an accidental short circuit.
- 2** Remove (2) 9/32" hex-head screws from the knee bolster panel.
- 3** Pull down on the panel and remove the 9/32" hex-head screws exposed on the bottom of the dash trim bezel.
- 4** Remove (1) Phillips screw above the instrument cluster.
- 5** Unclip the dash trim bezel and remove.
- 6** Remove (2) 9/32" hex-head screws securing the factory head unit and disconnect the wiring.

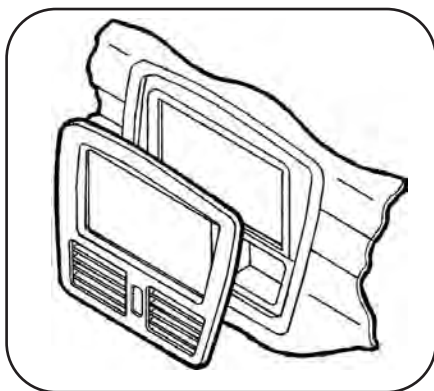
**SUZUKI • AERIO 2002**

- 1** Disconnect the negative battery terminal to prevent an accidental short circuit.
- 2** Unclip the dash trim bezel and remove.
- 3** Remove (4) Phillips screws securing the factory head unit and disconnect the wiring.
