Vehicle Application:

Chevrolet Silverado / Sierra 6.5' Bed 1988-1998 Part Number: 19005

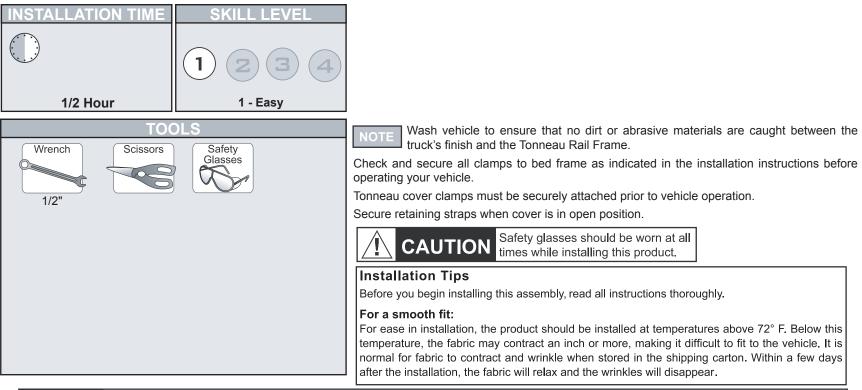
WARNING The buckle of each retaining strap and both clamps must be fastened securely to avoid damage to personal property or possible personal injury.

If the vehicle has an Over-the-Rail Bedliner, use a certified installer to perform the initial installation. Modifications to the Bedliner may be required.

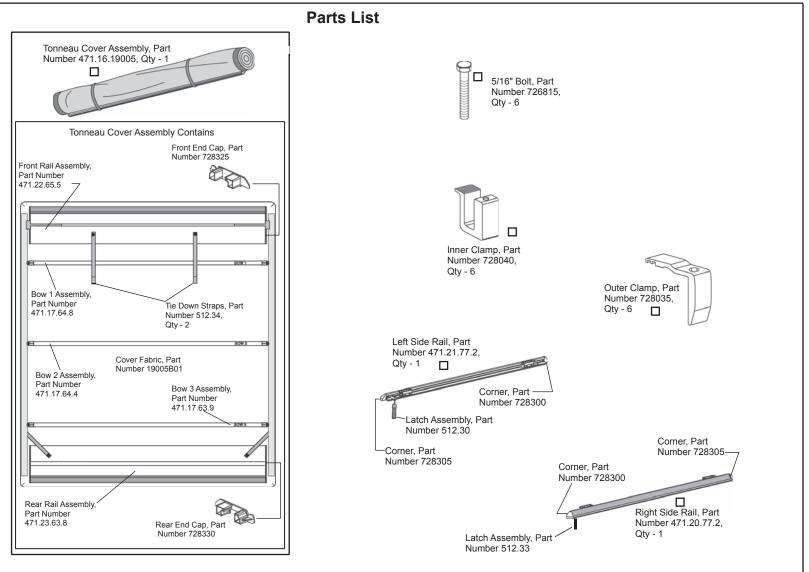
5/16" Bolt

Assemble Clamps

Use a 5/16" Bolt to secure an Outer Clamp to an Inner Clamp. Repeat for six (6) assemblies.

Place Side Rails on Bed

Locate the 2 side rails. Remove the protective tape on the bottom of each rail and place the rail on the bed on each side of the vehicle.

Once the rails are on the bed, align the front edge of each Side Rail, with the inside edge of the front bulkhead.
