#### Vehicle Application:

Ford Ranger/Mazda B-series 6' bed 82-11 Ranger, 94-09 Mazda Part Number: 19030

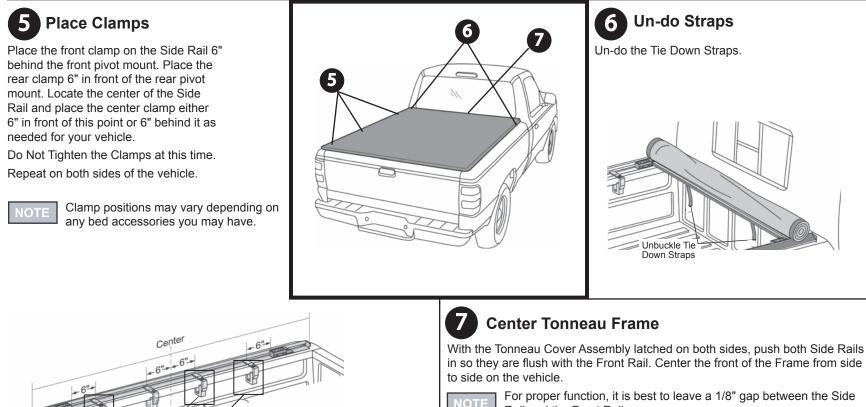
in so they are flush with the Front Rail. Center the front of the Frame from side

Rail and the Front Rail.
