### **Vehicle Application:**

Dodge Dakota

6.5' bed 87-2004

Part Number: 19061

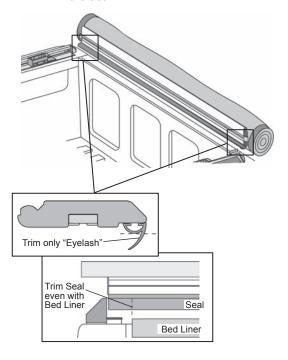
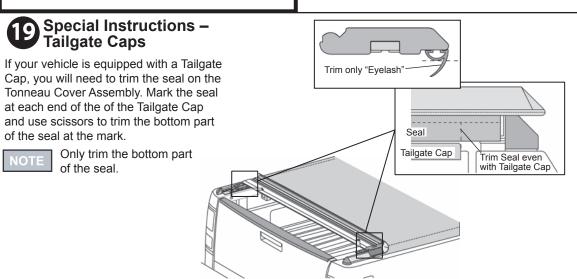
# Special Instructions – Bed Liners

If your vehicle is equipped with a Bed Liner that comes up over the front bulkhead, you will need to trim the seal on the Tonneau Cover Assembly. Mark the seal at each end of the of the Bed Liner and use scissors to trim the bottom, "eyelash", part of the seal at the mark.

Only trim the bottom, "eyelash", part of the seal.
