Vehicle Application:

•Ford F150,

6.5' bed 97-03 F150, 04 Heritage & 97-00 F250 Light Duty Part Number: 19110

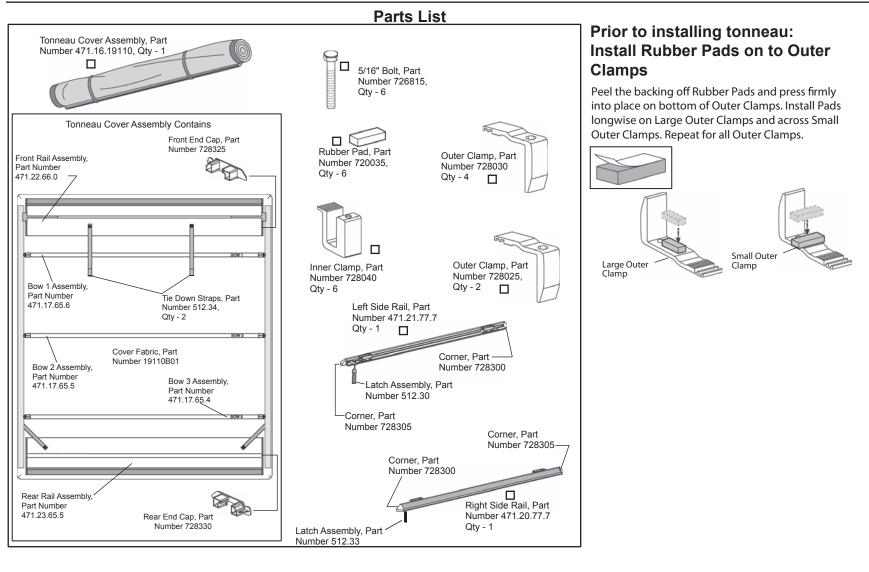
5/16" Bolt

Use a 5/16" Bolt to secure an Outer Clamp to an Inner Clamp. Repeat for six (6) assemblies.

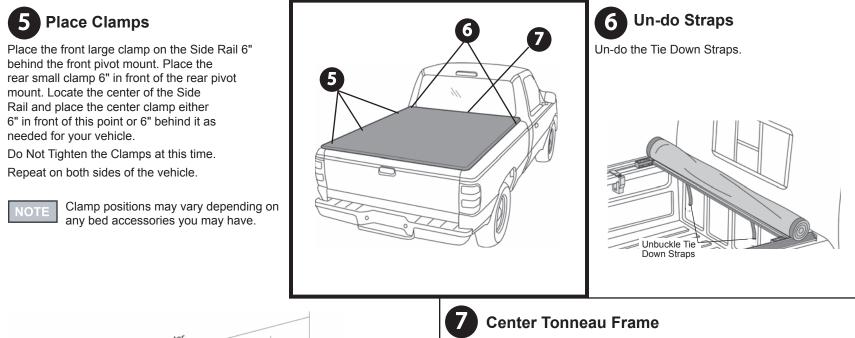
With the Tonneau Cover Assembly latched on both sides, push both Side Rails in so they are flush with the Front Rail. Center the front of the Frame from side to side on the vehicle.

For proper function, it is best to leave a 1/8" gap between the Side Rail and the Front Rail.
