Vehicle Application: •Ford F250/F350 6.8' bed •1999 - 2016 Part Number: 19140

#### 3 Secure Tonneau Cover Assembly to Passenger Side Rail

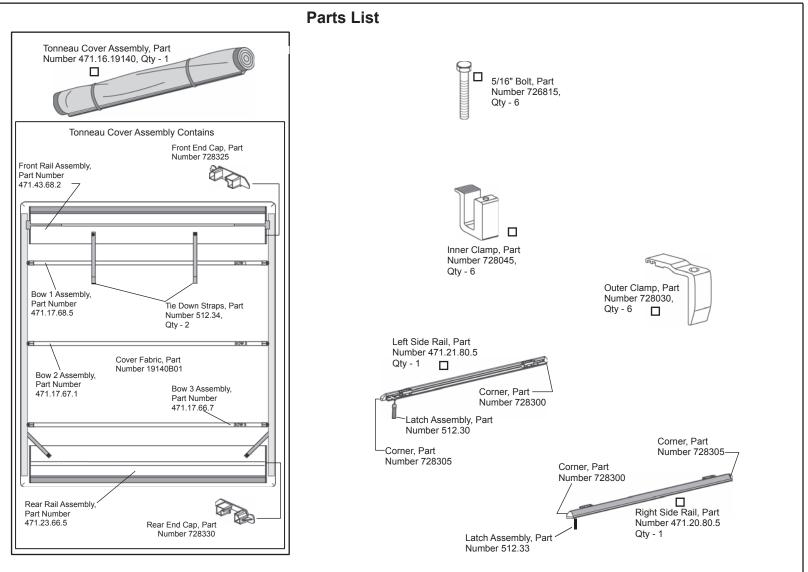
5/16" Bolt

# Use a 5/16" Bolt to secure

an Outer Clamp to an Inner Clamp. Repeat for six (6) assemblies.

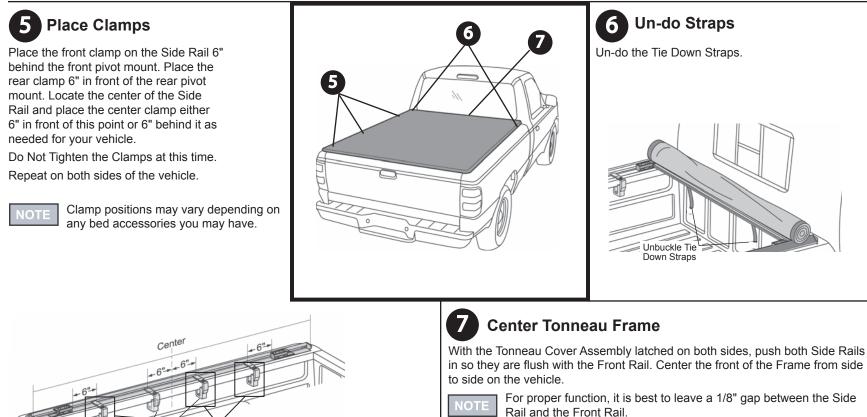
Place the Driver's Side Rail into the Tonneau Cover Assembly. Make sure the cover assembly latch is fully engaged into the slot on the Side Rail and that the cover assembly is flush against the Side Rail.
