#### Vehicle Application:

Chevrolet Colorado/GMC Canyon 6' bed €IËG€FG Part Number: 19152

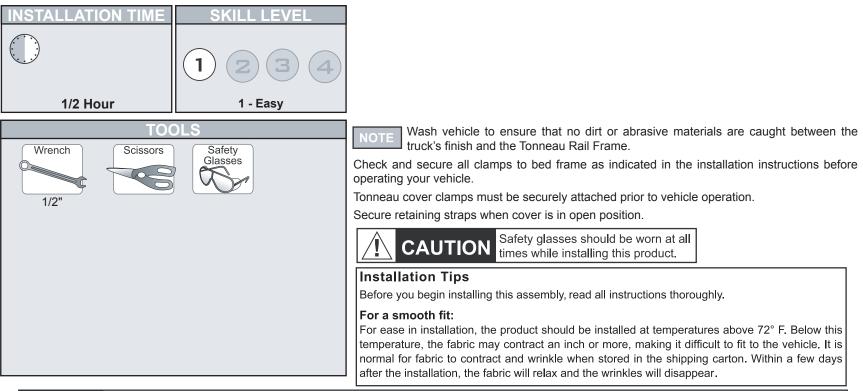
WARNING The buckle of each retaining strap and both clamps must be fastened securely to avoid damage to personal property or possible personal injury.

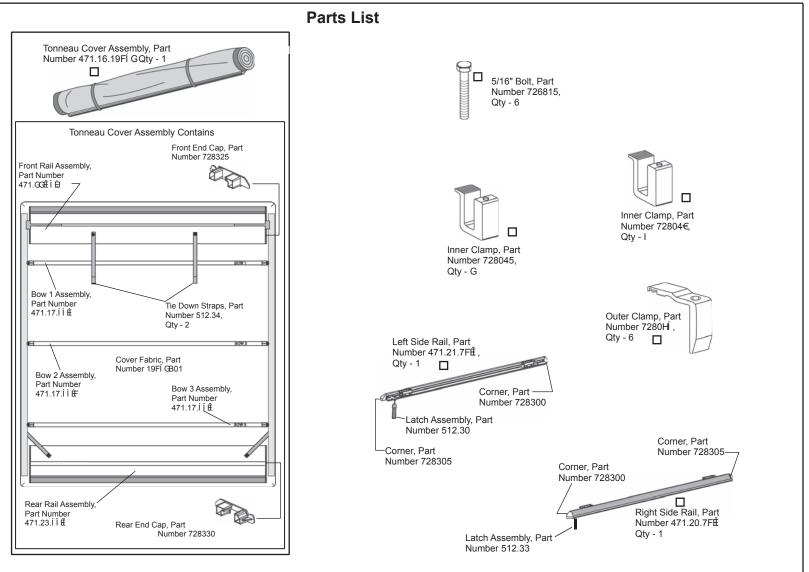
Use a 5/16" Bolt to secure an Outer Clamp to an Inner Clamp. Repeat for six (6) assemblies.
