Vehicle Application:

• Chevrolet Silverado / Sierra 5.8' Bed

• 2007 - 2013 1500 & 2014 HD

• Part Number: 19212

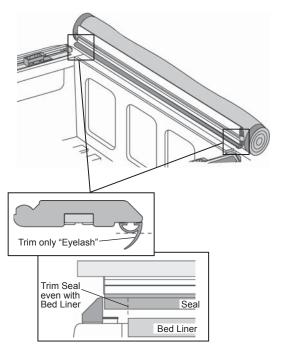
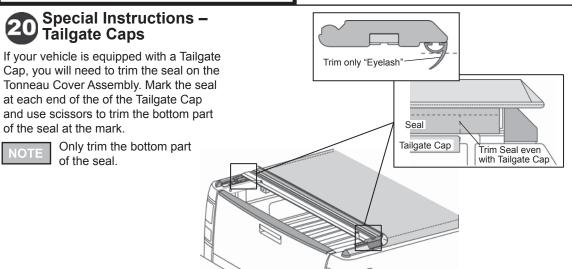
Special Instructions – **Bed Liners**

If your vehicle is equipped with a Bed Liner that comes up over the front bulkhead, you will need to trim the seal on the Tonneau Cover Assembly. Mark the seal at each end of the of the Bed Liner and use scissors to trim the bottom, "eyelash", part of the seal at the mark.

Only trim the bottom, "eyelash", part of the seal.
