Vehicle Application:

Chevrolet Silverado/GMC Sierra 5.8' bed 2014-Current 1500, & 2015 - Current HD

• Part Number: 19216

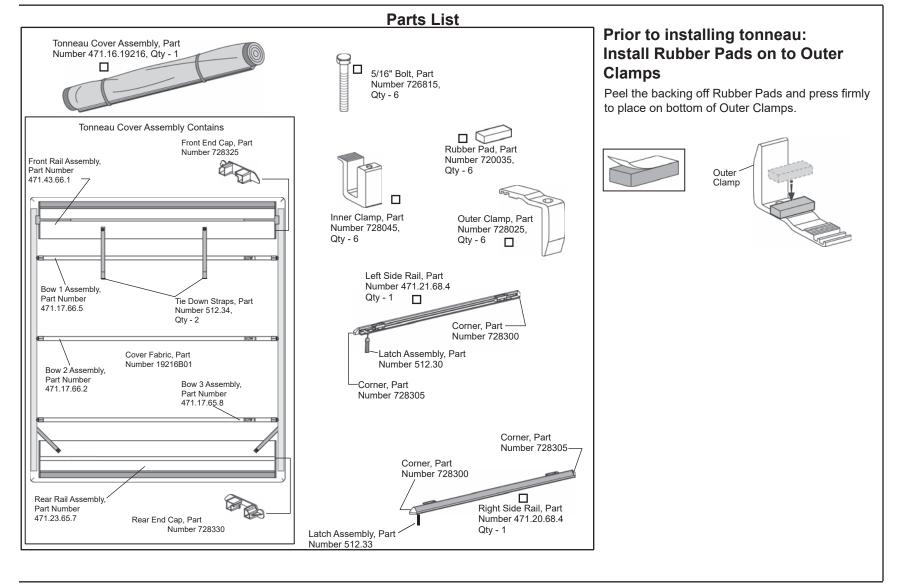
WARNING The buckle of each retaining strap and both clamps must be fastened securely to avoid damage to personal property or possible personal injury.

If the vehicle has an Over-the-Rail Bedliner, use a certified installer to perform the initial installation. Modifications to the Bedliner may be required.

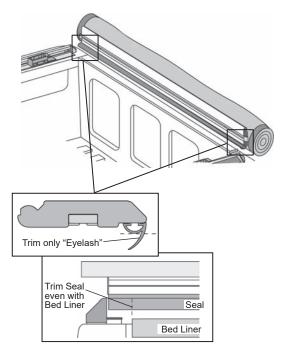
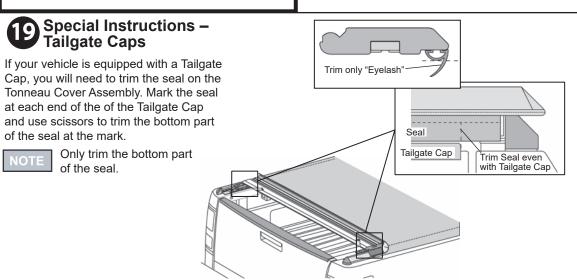
Special Instructions – Bed Liners

If your vehicle is equipped with a Bed Liner that comes up over the front bulkhead, you will need to trim the seal on the Tonneau Cover Assembly. Mark the seal at each end of the of the Bed Liner and use scissors to trim the bottom, "eyelash", part of the seal at the mark.

Only trim the bottom, "eyelash", part of the seal.
