Vehicle Application:

- Chevrolet Silverado/GMC Sierra 8' bed
- 2019-Current (new body style)
- Part Number: 19226

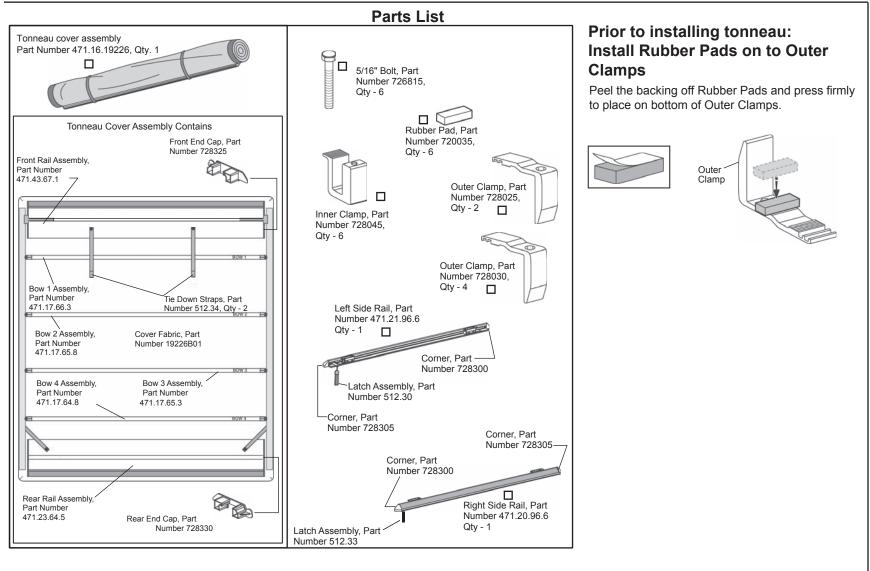
-5/16" Bolt

### Assemble Clamps

Use a 5/16" Bolt to secure an outer clamp to an Inner Clamp. Repeat on all Clamp assemblies.
