68 RFE VALVE BODY UPGRADE

Part #:	1030360	2007-11 (Early Model)
Part #:	1030361	2010-12 (Late Model)

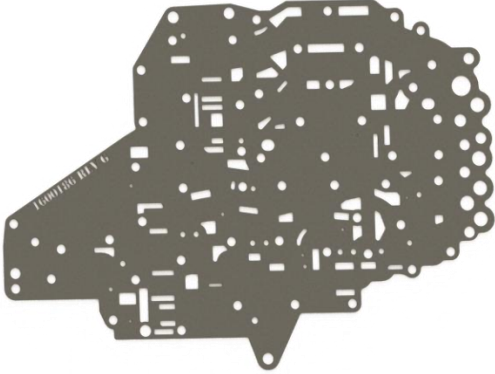
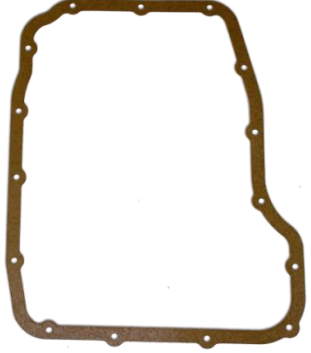
Kit Contents for 1030360			
1030369	4799778	1600186	1601523

68 RFE Pressure Controller	Clutch Feed Seal	Valve Body Plate	Gasket
Qty : 1	Qty : 3	Qty : 1	Qty : 1

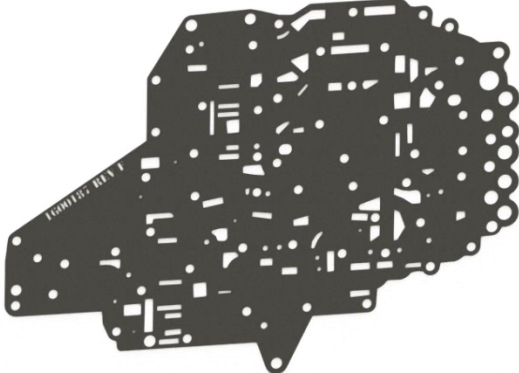
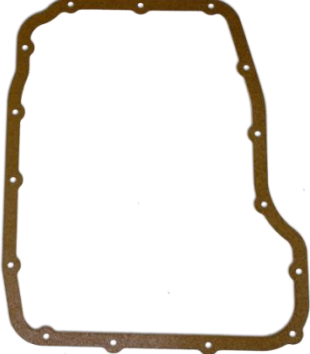
Kit Contents for 1030361			
1030369	4799778	1600187	1601523

68 RFE Pressure Controller	Clutch Feed Seal	Valve Body Plate	Gasket
Qty : 1	Qty : 3	Qty : 1	Qty : 1

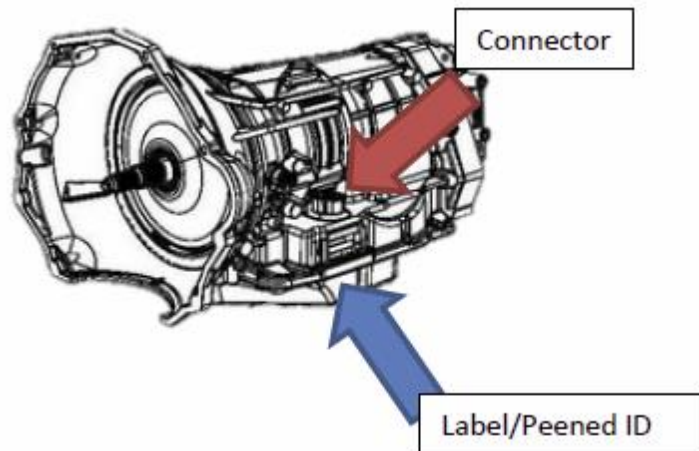
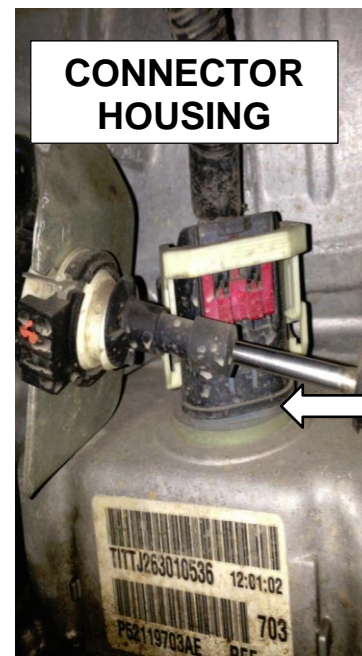
The transmission main electrical connector is located on the driver's side of the transmission. The color of the connector protruding from the transmission will be white or grey and will determine the application.

White Connector = Early Model
(Plate 1600186)

Grey Connector = Late Model
(Plate 1600187)

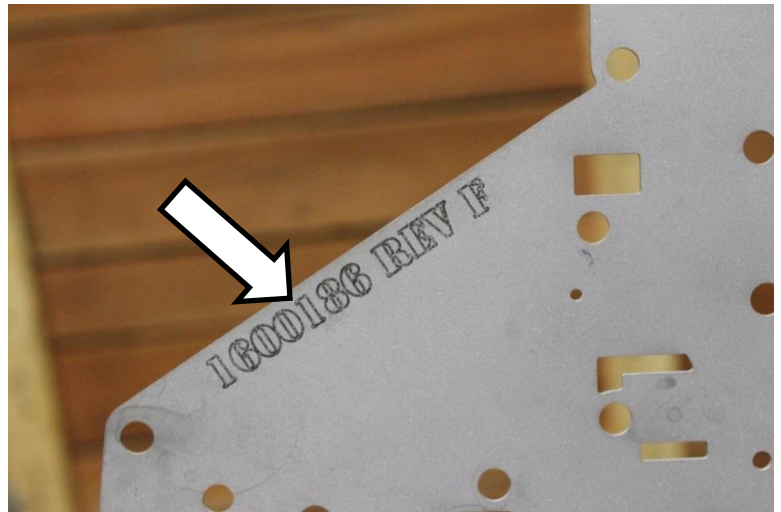
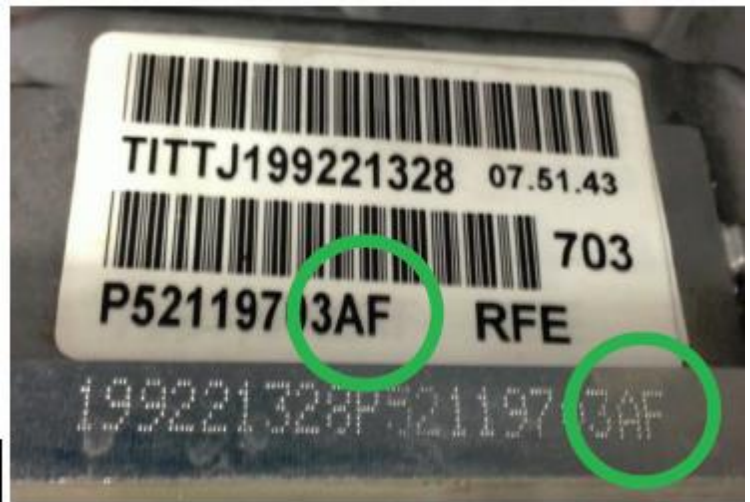
Another method to check the model year is by the label or peened number on the side of the case. These numbers can also be found on the driver's side of the transmission right below the main connector.

The two letters will indicate an early or late model.

AA	Early Model
AB	Early Model
AC	Early Model
AD	Early Model
AE	Late Model
AF	Late Model

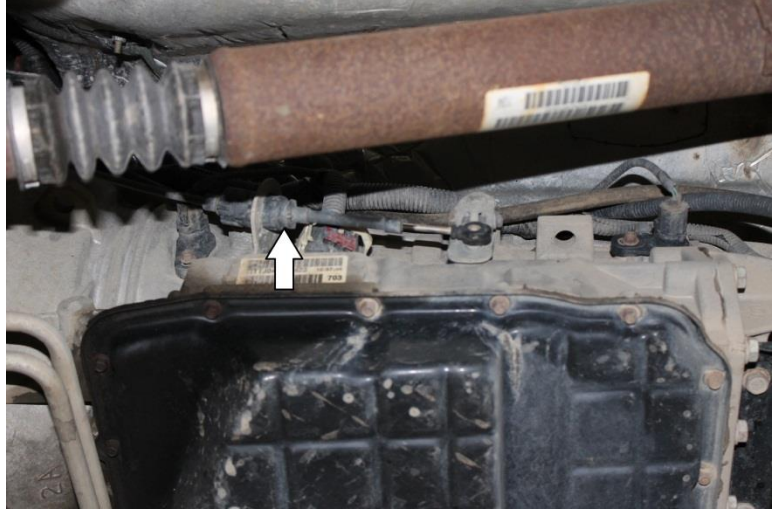
4. Remove shifter cable from transmission for better access to the main electrical connector.

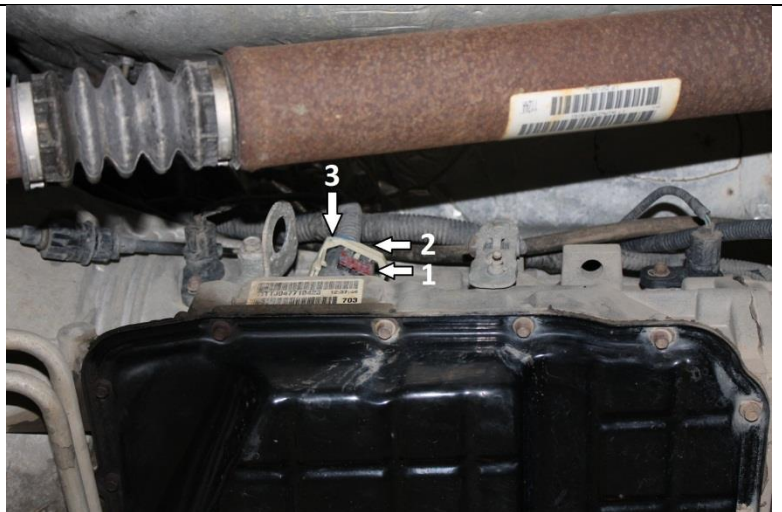
5. To remove connector, push red tab (1) downwards. Then, press the black tab (2) which will allow the white handle (3) to be rotated downwards, releasing the connector from the transmission.

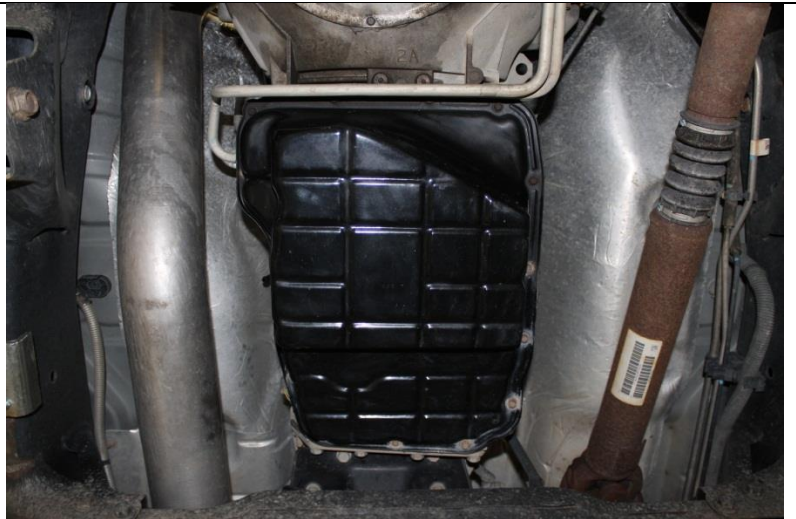
7. Remove 14 of the 15 transmission pan bolts (8mm). Loosen the remaining bolt but leave in place to keep the pan from falling. The transmission cooler lines may need to be moved to access some of the bolts, gently pry them out of the way.

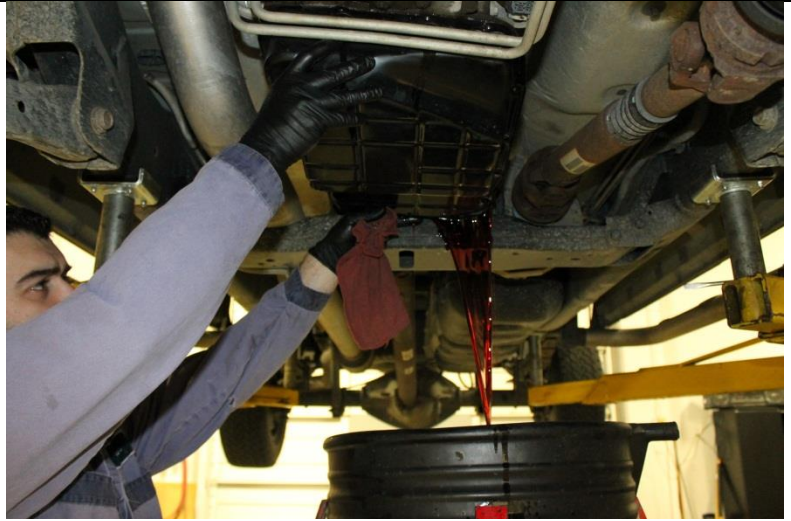
8. Tap pan with a mallet to break the silicone gasket seal. Allow fluid to drain. Remove last screw and drain remainder of fluid.

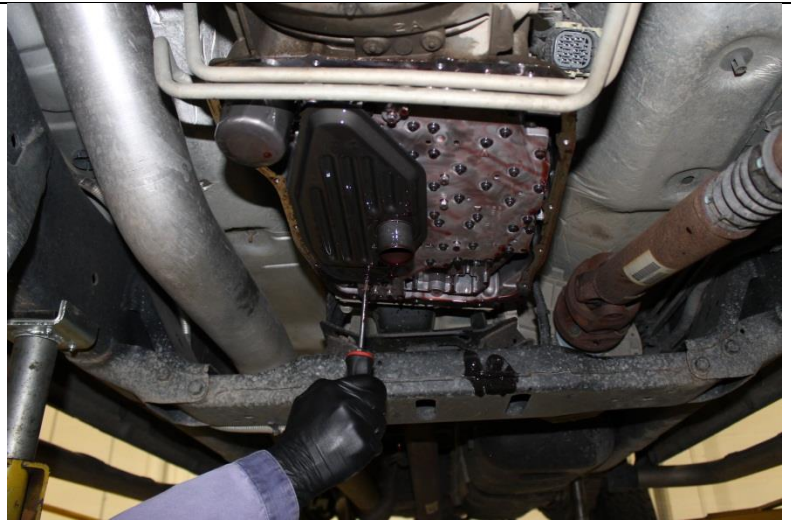
9. Remove transmission filter by removing the one T25 Torx screw.

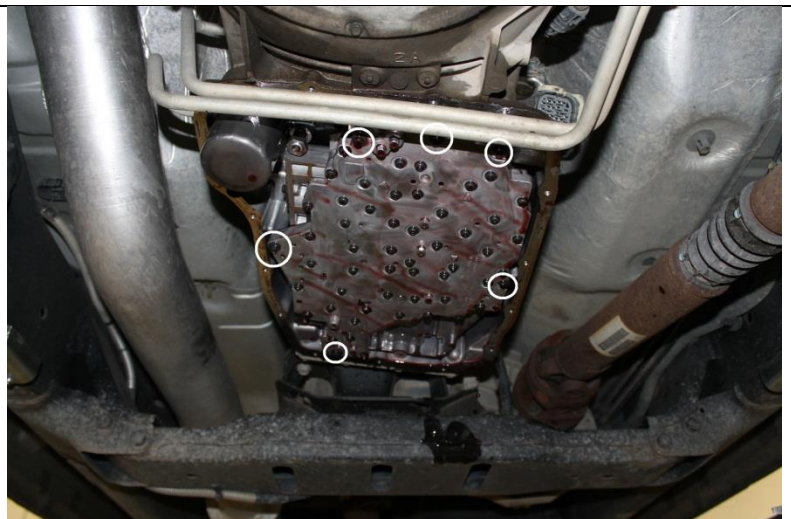
10. Remove the six 8mm bolts securing the valve body to the transmission. Drain valve body of fluid. To remove valve body from transmission, wiggle it while pulling downwards to work the electrical connector through the case.

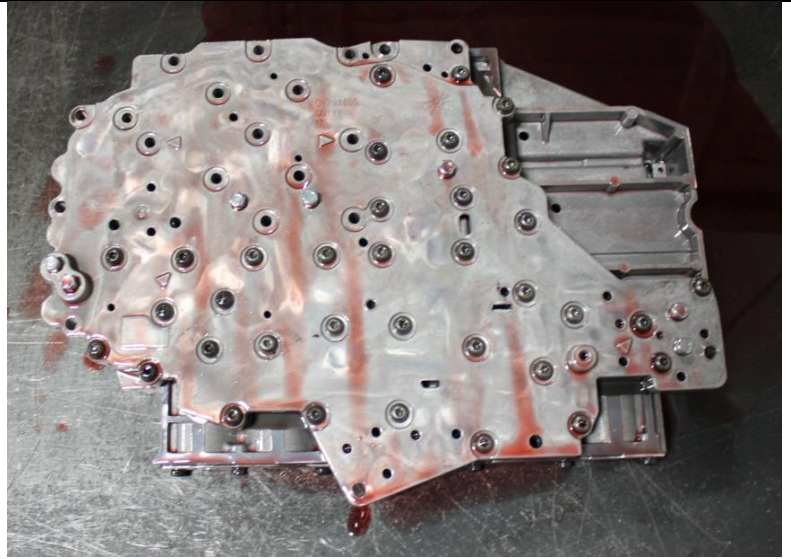
11. Place the valve body on a clean work surface.

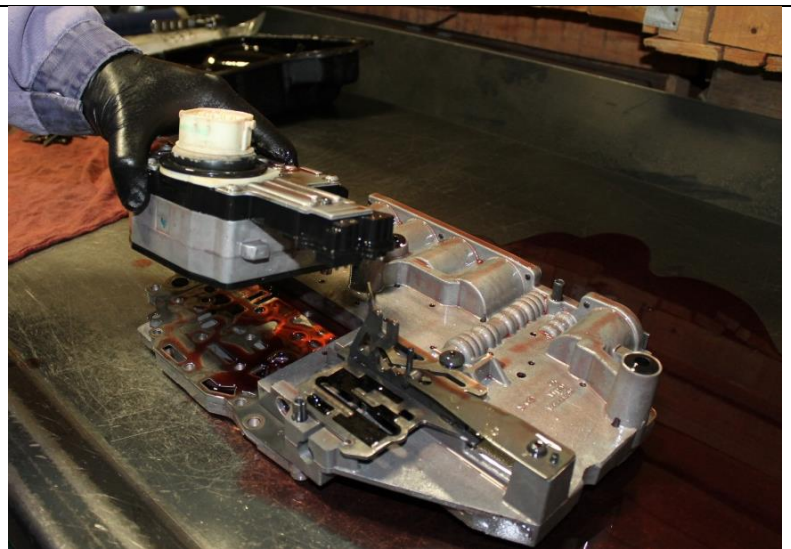
12. Remove fifteen T25 Torx screws securing the solenoid pack to the valve body, remove solenoid pack and place it to the side.

Note: All bolts are the same length.

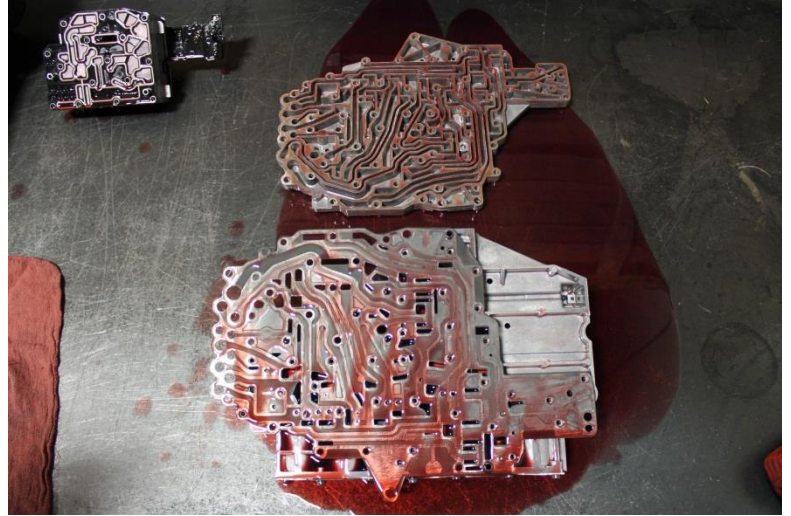
14. Carefully separate the two halves of the valve body. Separate as shown in pictures – *do not invert the larger (top) portion as it contains plastic check balls*. The two halves will have to be wiggled apart as the alignment dowels will be holding them together.

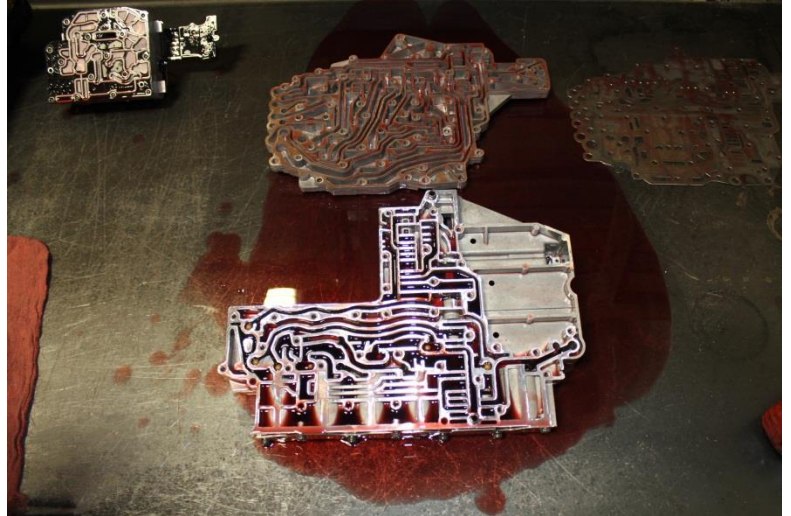
15. Remove old separator plate.

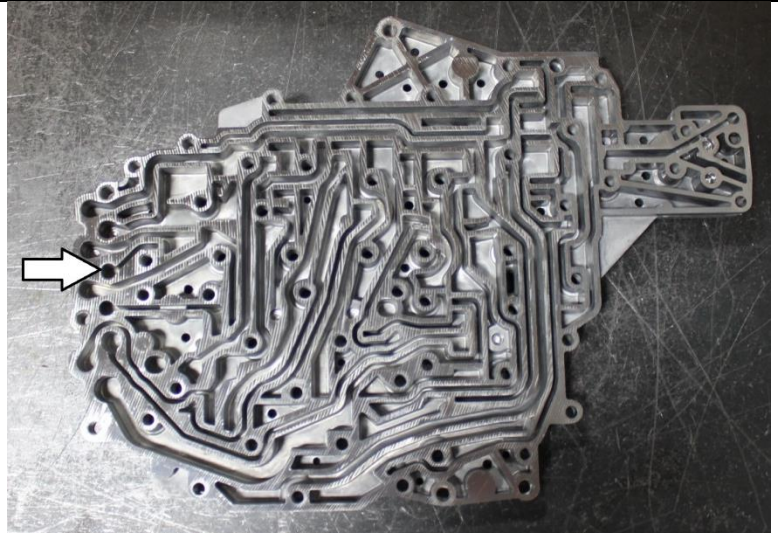
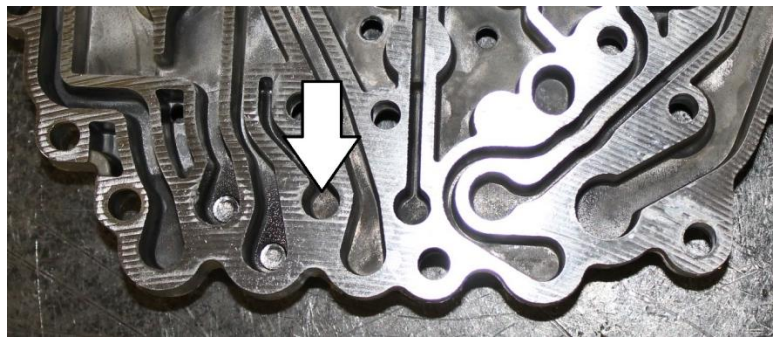
16. Thoroughly clean the bottom (smaller) half of the valve body. Locate the passage to be drilled.

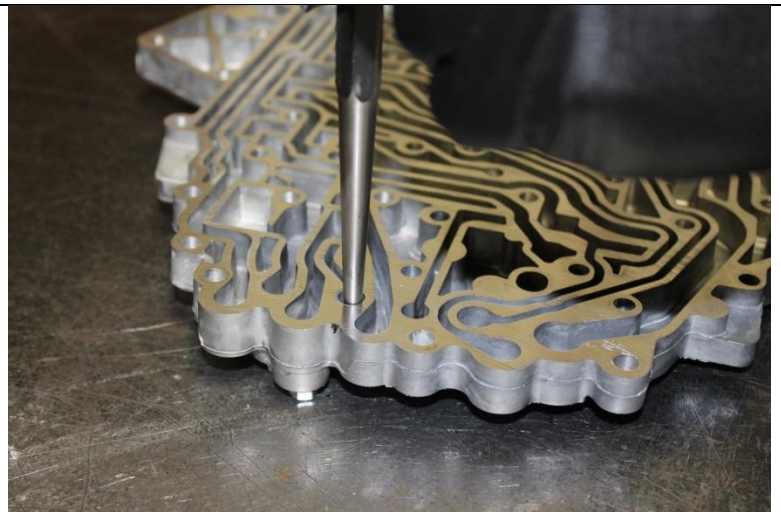
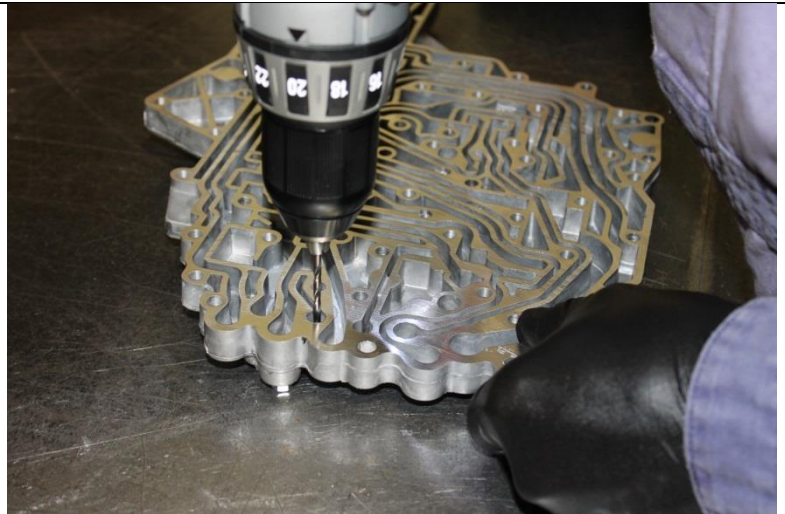
17. Punch center of hole using a center punch.

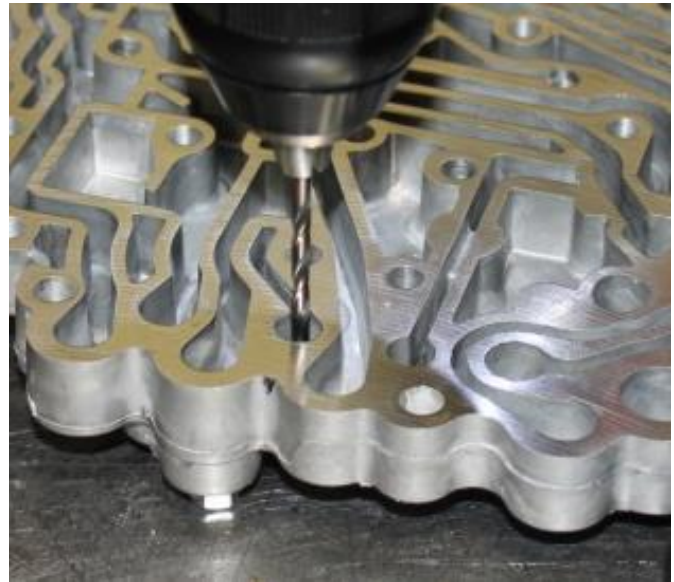
18. Drill hole with 1/8" drill bit.

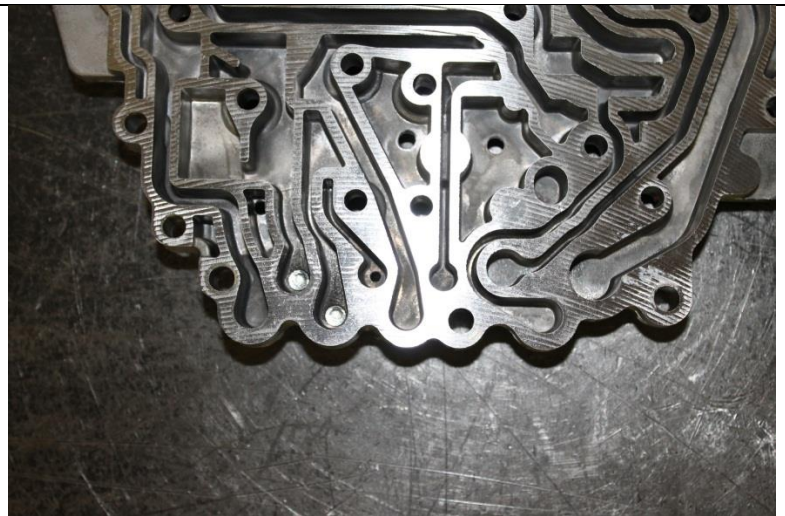
19. Thoroughly remove any burrs and clean all shavings from the valve body. It is imperative that no contaminants are left as they may cause transmission damage.

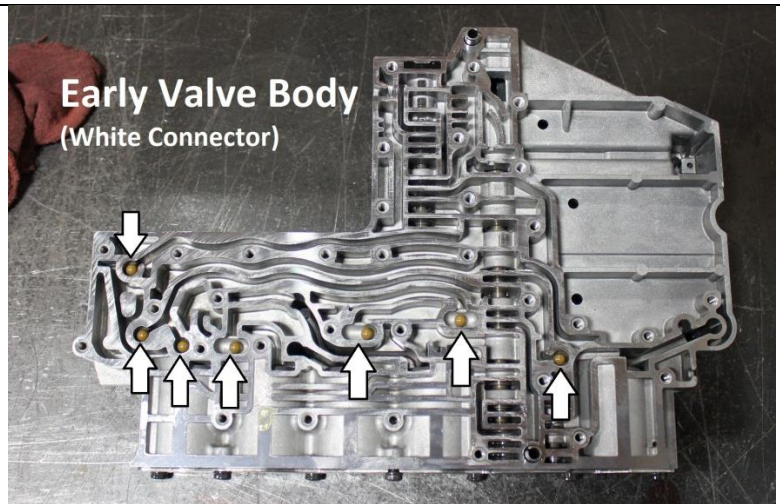
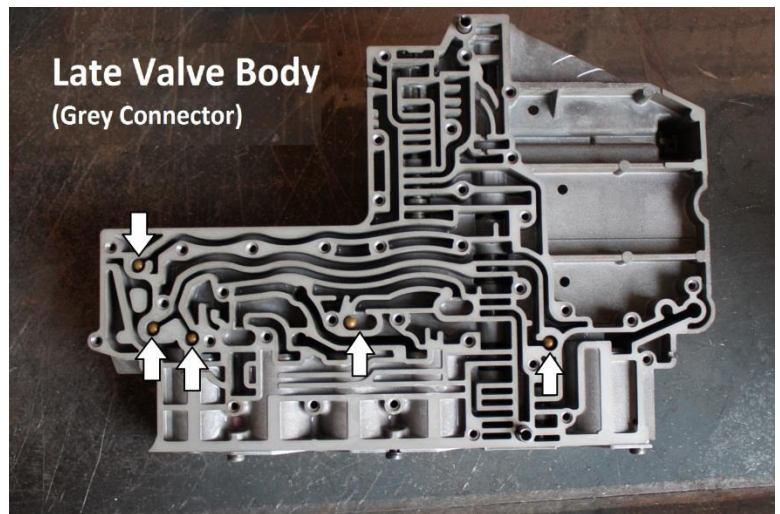
20. Ensure that all the check balls are still in the correct locations in the upper half of the valve body. Early model valve bodies (identified by white electrical connector on solenoid pack) have seven balls. Late models (gray connector) only have five.

If this part has been contaminated in any way, it must be thoroughly cleaned before reassembly.

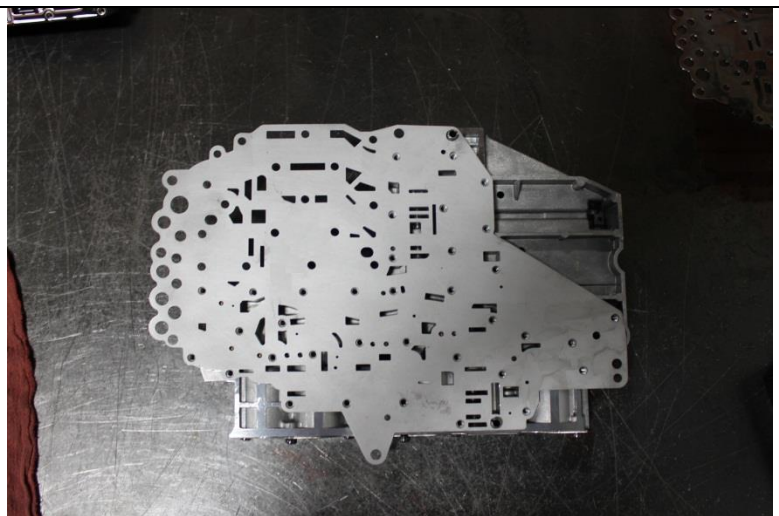
21. Install BD separator plate. Ensure it fits flat on the valve body.

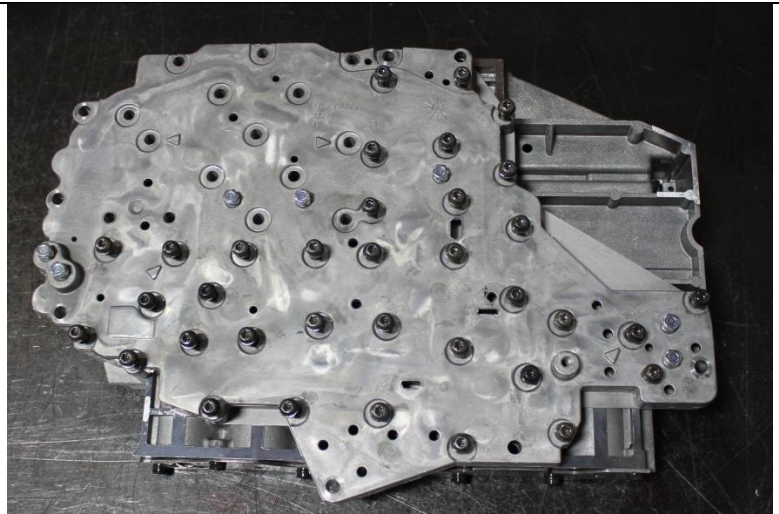
22. Re-install bottom (smaller) half of valve body. Ensure it fits flat on the separator plate. It may need to be worked downwards while rocking to be installed over the dowels. Install attaching screws so they are fully seated but do not tighten until the solenoid pack has been installed.

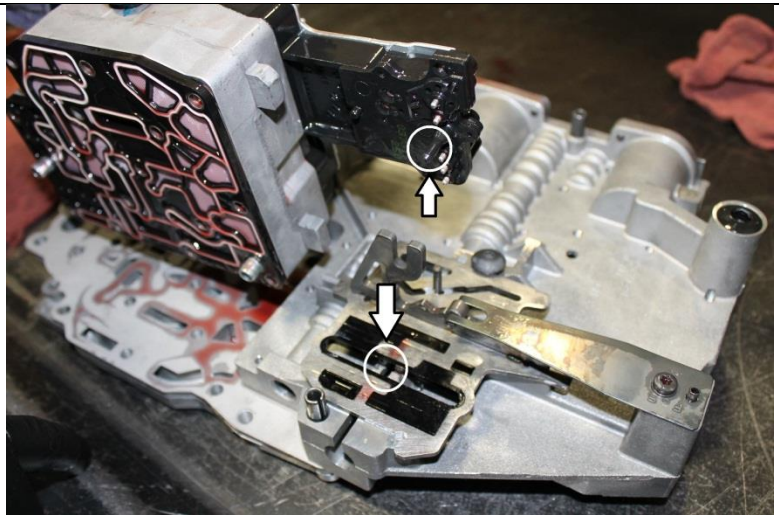
23. Re-install solenoid pack onto valve body. Be sure to properly align the pin on the solenoid pack with the slot on the valve body. Due to the alignment dowels, the valve body may need to be wiggled down into position. Install solenoid pack attaching screws. Install remaining Torx screws to fasten the solenoid pack to the valve body.

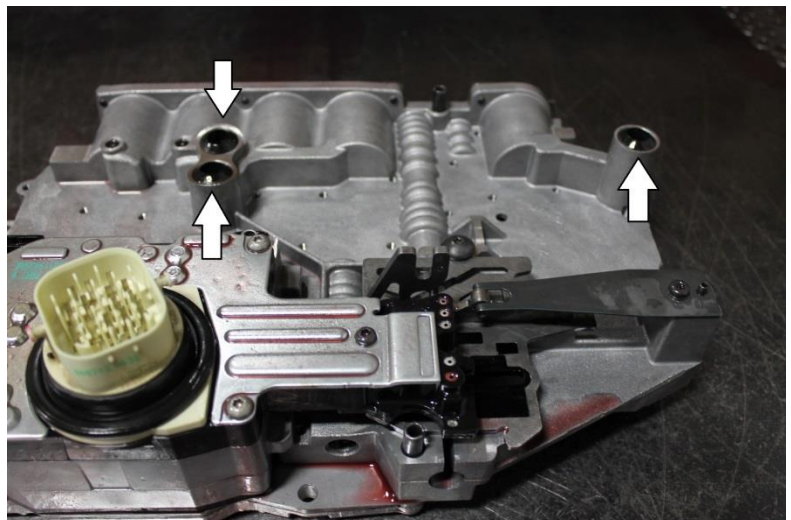
24. Torque all valve body Torx screws to 55 in-lbs, working from the center outwards. Carefully check that no screws were missed.

25. Inspect the three rubber seals on the top of the valve body, replace with supplied seals if they are nicked or otherwise damaged. Ensure the seal mating surface on the transmission is clean.

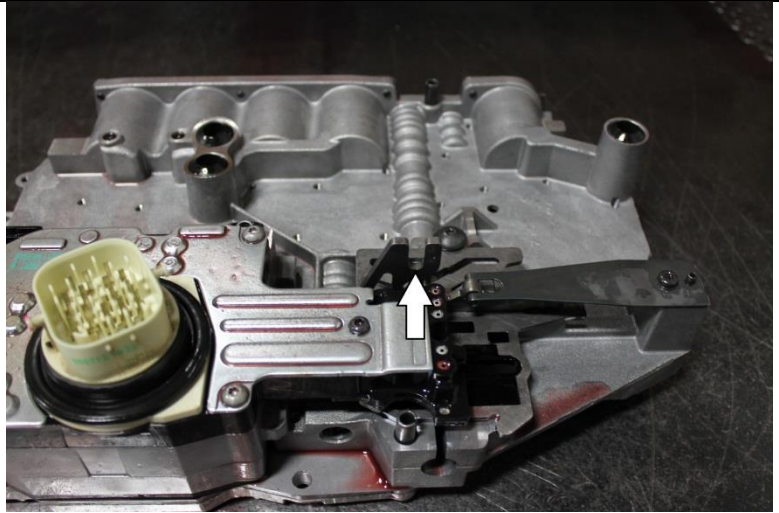
26. Wipe clean the bore on the transmission case around the electrical connector. Scrape all old silicone gasket material (if any) from the oil pan mating surfaces.

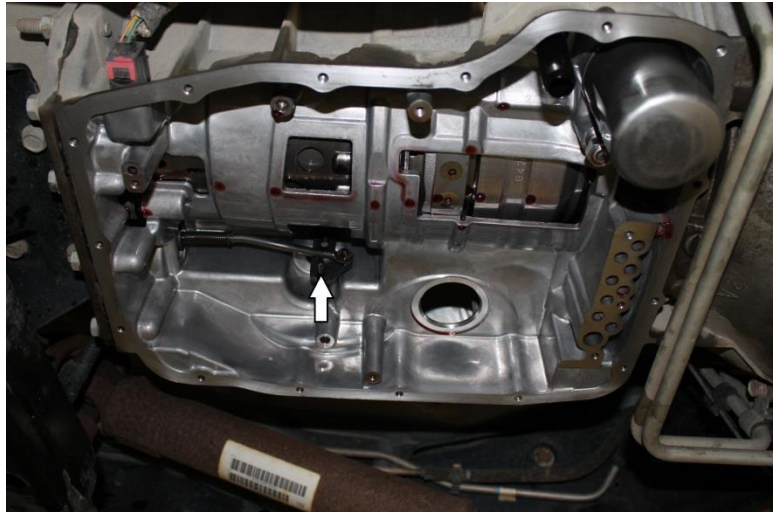
27. Check that the shift lever on the valve body lines up with the shift lever on the transmission and lift the valve body back into the transmission. Start the 8mm screws by hand, do not tighten yet. Work the shift lever on the outside of the transmission case by hand to ensure that the lever is making contact with the valve body correctly.

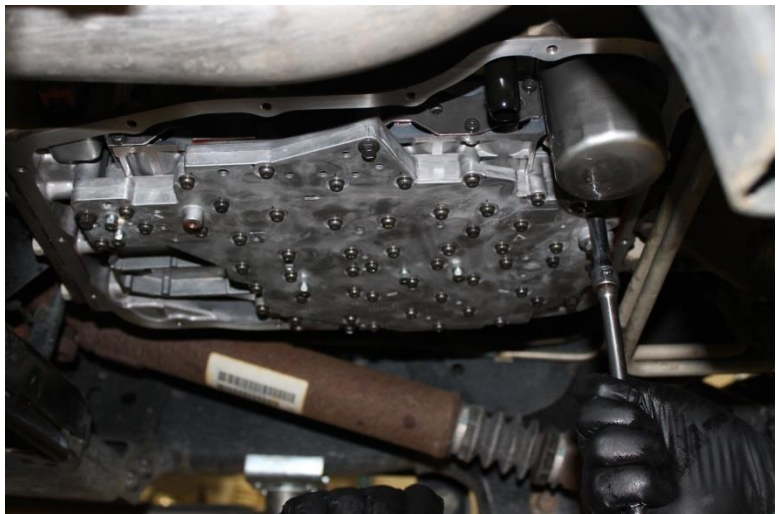
28. Torque the valve body attaching bolts to 105 in/lbs.

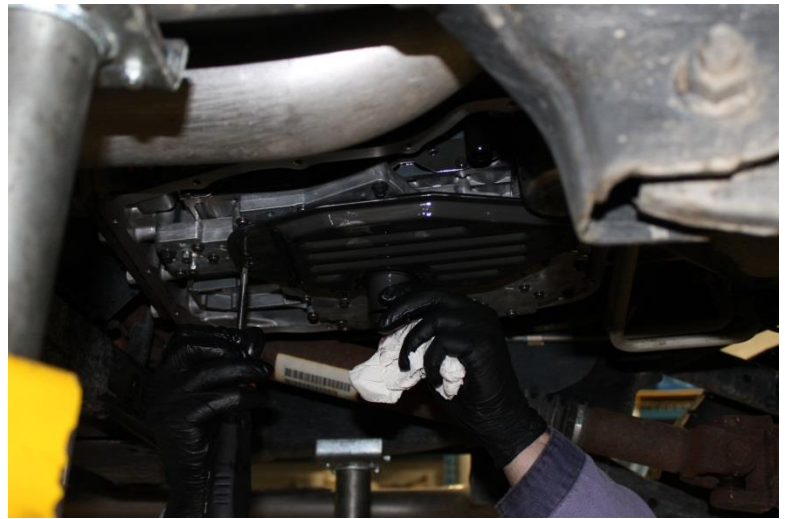
29. If desired, install new filter(s). Otherwise, reinstall the filter/pickup assembly. Torque to 55 in/lbs.

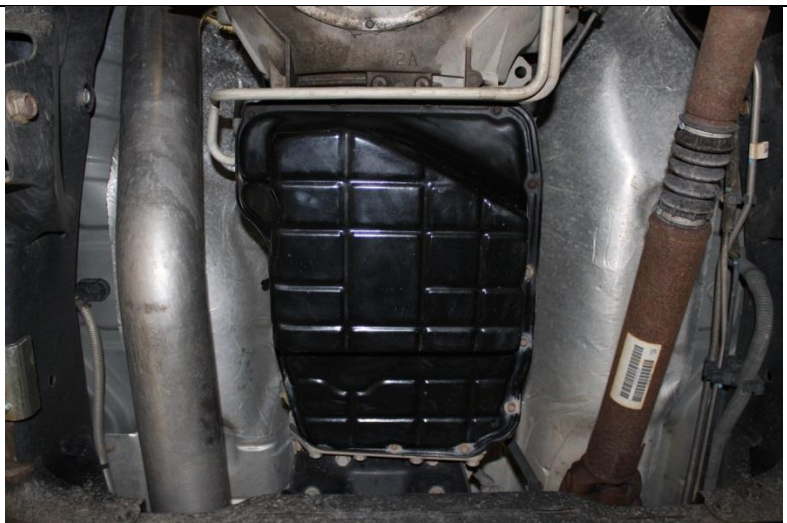
30. Place the supplied gasket on the transmission pan. Hold pan below transmission and install attaching screws. Torque the pan screws to 84 in/lbs.

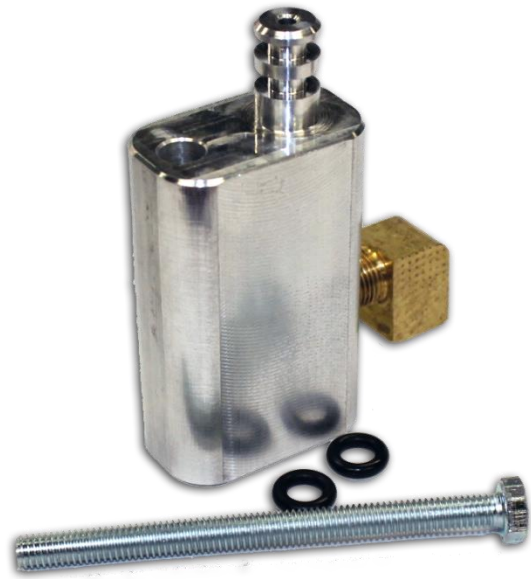
ADAPTER KIT BD# 1061529

37. Note. If you would like to verify the increases in line pressure, use adapter kit (BD 1061529) in conjunction with a 300psi gauge. Readings will be between 50-250psi depending on throttle and driving conditions.

Use this kit with a 300 psi gauge.
