•Chevrolet Colorado / GMC Canyon 5' Short Bed 2004 – 2007 Part Number: 17152

17152 pg. 2

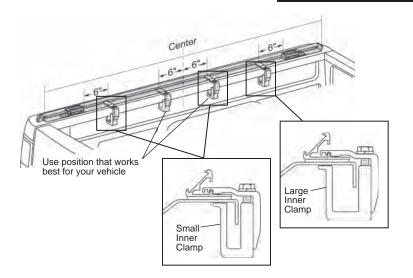
Install Tonneau Cover Assembly

Standing in the bed if necessary, slide the ends of the Front Rail on the Tonneau Cover Assembly into the front Pivot Mounts on the Side Rails.

Both front latches must remain engaged and the wing bolts tight while the cover is on the vehicle.

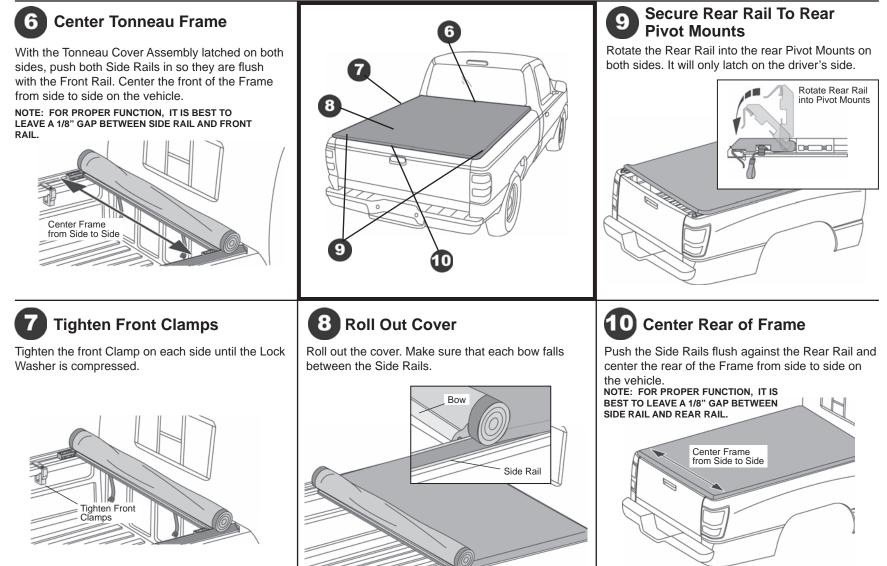
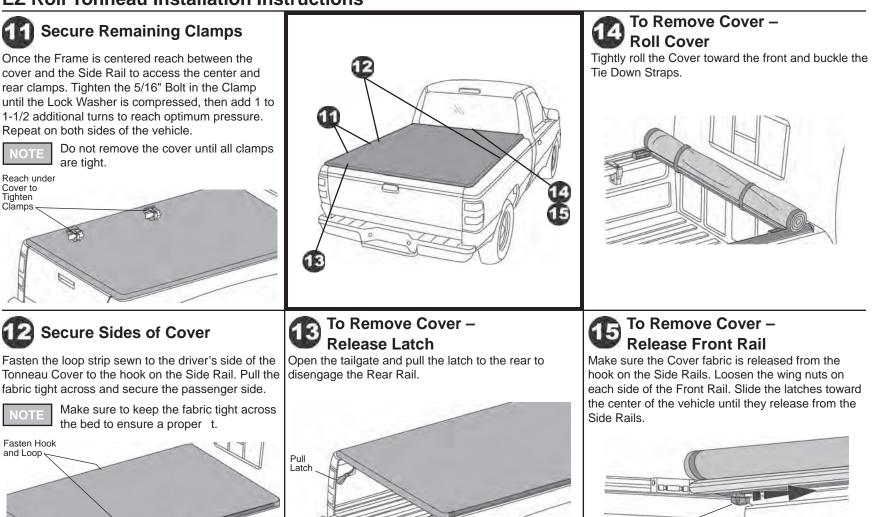
Secure Tonneau Cover Assembly

Unbuckle the Tie Down Straps. Press down firmly on the end of the cover. Loosen the wing bolt and slide the latch into the Side Rail. Tighten the wing nut. Repeat on both sides of the vehicle.

Loosen Latch on Both Sides and Slide to Center

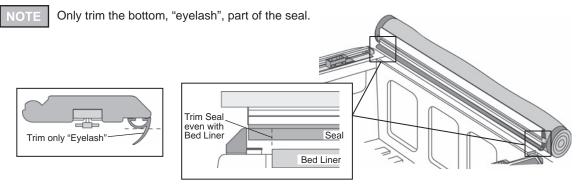
Special Instructions – . Bed Liners

If your vehicle is equipped with a Bed Liner that comes up over the front bulkhead, you will need to trim the seal on the Tonneau Cover Assembly. Mark the seal at each end of the of the Bed Liner and use scissors to trim the bottom, "eyelash", part of the seal at the mark.

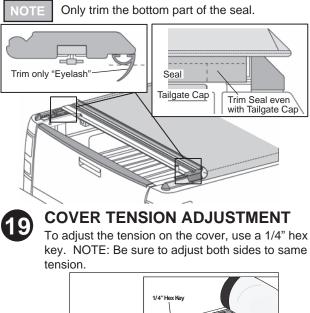
BSPECIAL INSTRUCTIONS -TAILGATE CAPS.

If your vehicle is equipped with a Tailgate Cap, you will need to trim the seal on the Tonneau Cover Assembly. Mark the seal at each end of the of the Tailgate Cap and use scissors to trim the bottom part of the seal at the mark.
