Vehicle Application:

•Chevrolet Silverado / GMC Sierra Fleetside 6.5' Short Bed ('99 New body Style & '07 Classic Body Style) 1999 – 2007 Part Number: 17205

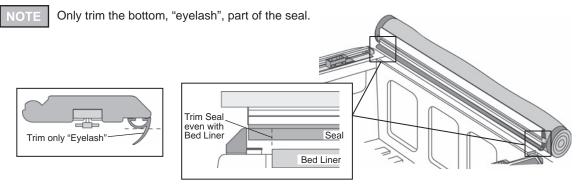
If your vehicle is equipped with a Bed Liner that comes up over the front bulkhead, you will need to trim the seal on the Tonneau Cover Assembly. Mark the seal at each end of the of the Bed Liner and use scissors to trim the bottom, "eyelash", part of the seal at the mark.

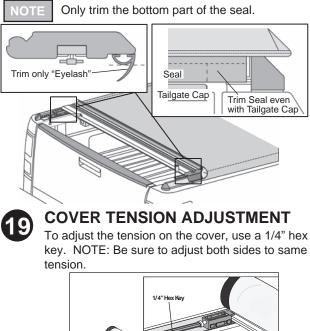
If your vehicle is equipped with a Tailgate Cap, you will need to trim the seal on the Tonneau Cover Assembly. Mark the seal at each end of the of the Tailgate Cap and use scissors to trim the bottom part of the seal at the mark.
