•Chevrolet Sliverado / GMC Sierra Crew Cab 5.8' Short Bed ('07 Classic Body Style Only) 2004 – 2007 Part Number: 17209

5 **Install Tonneau Cover Assembly**

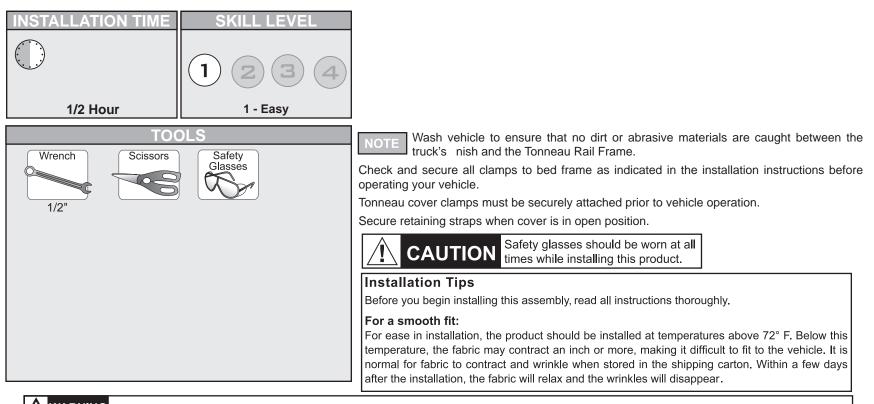
WARNING The buckle of each retaining strap and both clamps must be fastened securely to avoid damage to personal property or possible personal injury.

If the vehicle has an Over-the-Rail Bedliner, use a certified installer to perform the initial installation. Modifications to the Bedliner may be required.

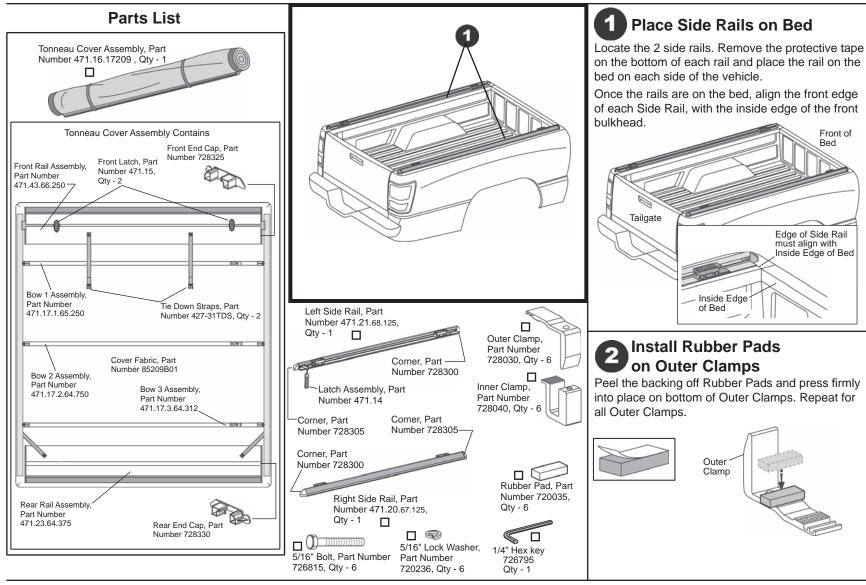
Use the 5/16" Bolts and 5/16" Lock Washers to assemble the Outer Clamps to the Inner Clamps. Create six (6) Clamp Assemblies.

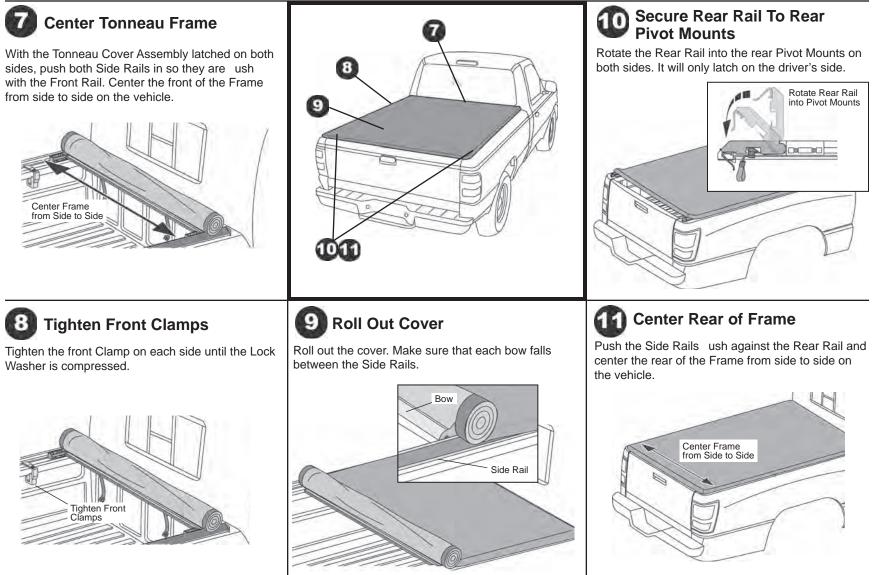
Use position that works Place a Large Outer Clamp Assembly best for your vehicle on the Side Rail 6" behind the front pivot mount. Place the a Small Outer Clamp Assembly 6" in front of the rear pivot mount. Locate the center of the Side Rail and place the remaining Large Outer Clamp Assembly either 6" in front of this point or 6" behind it as needed for your vehicle.

Do Not Tighten the Clamps at this time. Repeat on both sides of the vehicle.

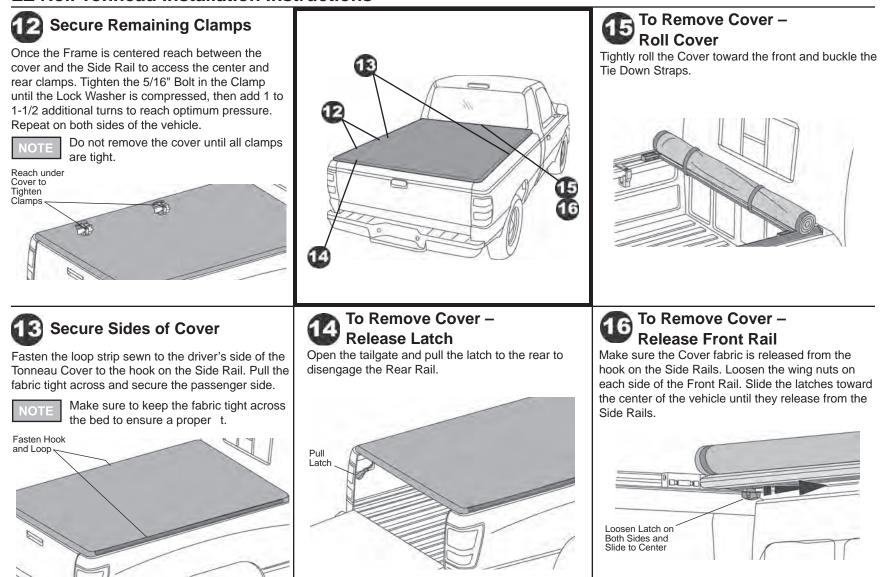
Standing in the bed if necessary, slide the ends of the Front Rail on the Tonneau Cover Assembly into the front Pivot Mounts on the Side Rails.

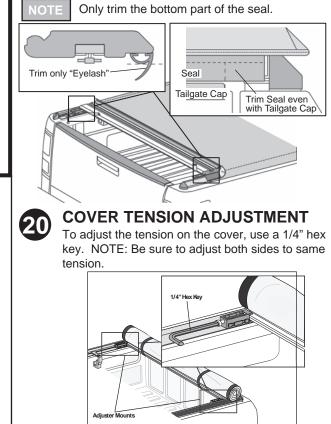
If your vehicle is equipped with a Tailgate Cap, you will need to trim the seal on the Tonneau Cover Assembly. Mark the seal at each end of the of the Tailgate Cap and use scissors to trim the bottom part of the seal at the mark.
