Installation instructions

For set # 8.3128

07-08 Toyota FJ Cruiser

03-08 Toyota 4Runner

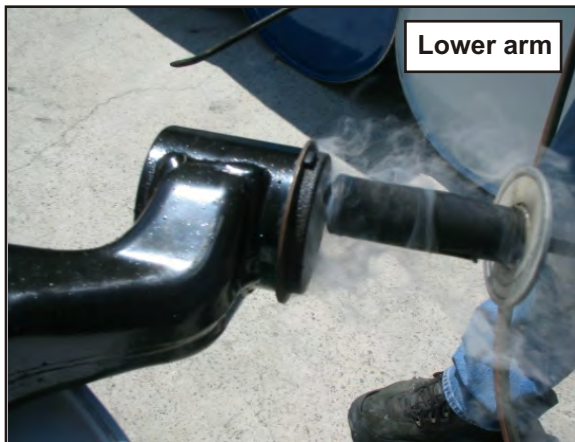
Do not remove the factory metal shells from the lower control arms, they must be reused. The inner metal sleeves and washers on the lower control arm must be reused. To remove the old rubber from the factory shells and inner sleeves, apply light heat evenly around the outside of the control arm outer metal shell, just enough to brake the bond with the rubber. Do the same on the inside of the sleeves on the lower control arms. When you see light smoke coming from the sides of the bushing the bond should be broken. At no time should there be any flames coming from the rubber, if there are any flames, you need to back off with the heat. Just push the old rubber and inner metal sleeve out. Let the outer metal shells and sleeves cool off before cleaning. Use a wire brush to remove any remaining old rubber. File off any sharp edges that will contact the new polyurethane bushings.

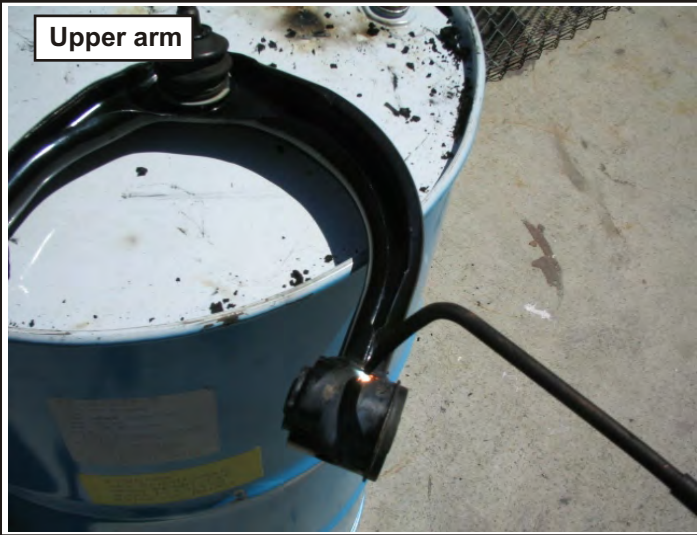
Upper arm

Do not remove the factory metal shells from the upper control arms, they must be reused. New inner metal sleeves are supplied for the upper control arms. To remove the old rubber from the factory shells and inner sleeves, apply light heat evenly around the outside of the control arm, just enough to brake the bond with the rubber. When you see light smoke coming from the sides of the bushing the bond should be broken. At no time should there be any flames coming from the rubber, if there are any flames, you need to back off with the heat. Just push the old rubber and inner metal sleeve out. Let the outer metal shells and sleeves cool off before cleaning.

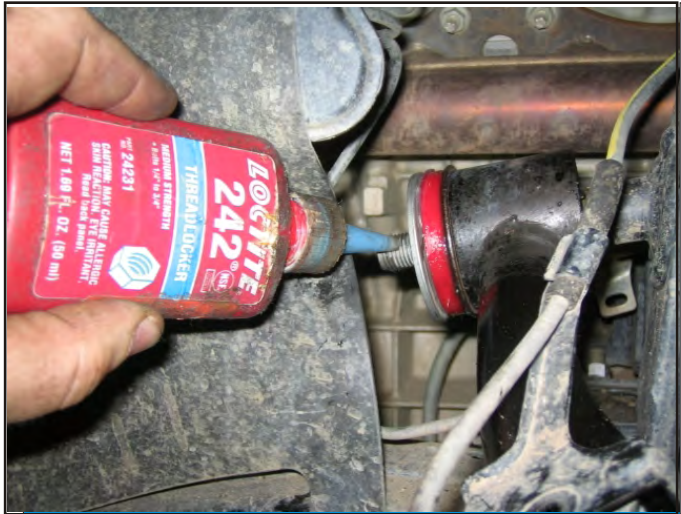
Use a wire brush to remove any remaining old rubber. File off any sharp edges that will contact the new polyurethane bushings. Apply grease to all metal parts that contact the polyurethane bushings. Apply thread locking compound to upper control arm through bolt then torque to 85 lb.
