99-2001

GM MULTI KIT

99-2001 AW-200GM

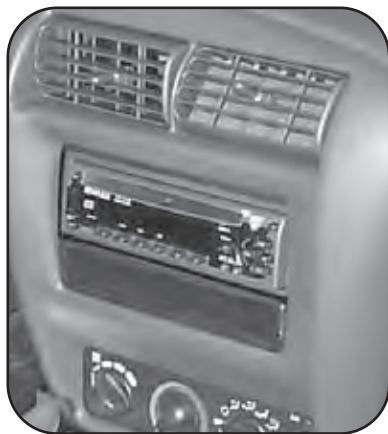
- A) Radio Housing
- B) Spacer
- C) Equalizer Dummy Plate
- D) Shaft Masks

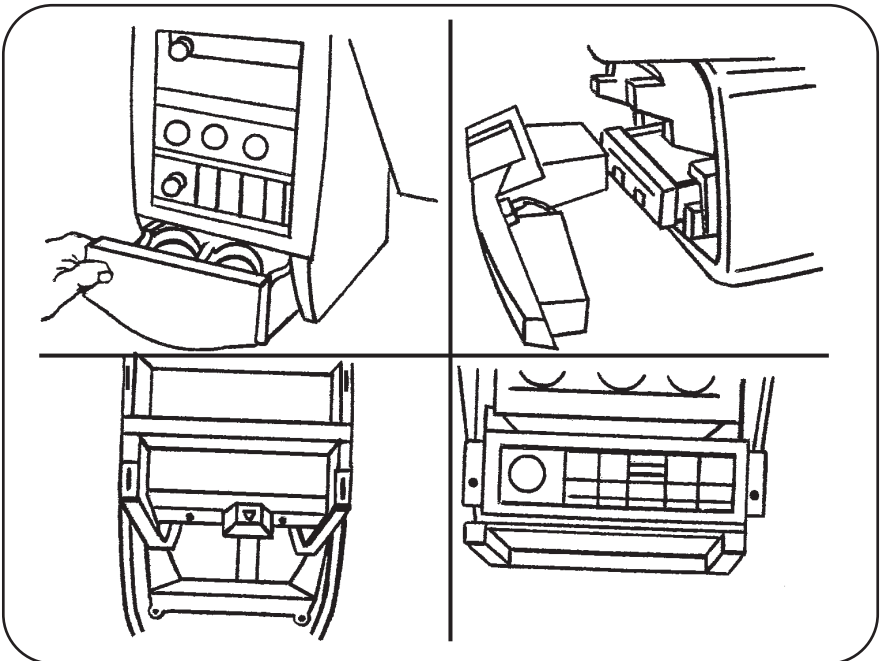
**CHEVROLET • Venture 2001-04
 OLDSMOBILE • Silhouette 2001-04
 PONTIAC • Montana 2001-04**

1. Open cup holders and remove (2) Phillips 7mm screws.
2. Unsnap and remove dual power outlet assembly from lower storage.
3. Open lower storage door and remove (2) 7mm screws inside.
4. Models with DVD - Remove DVD player and remove (2) 7 mm screws from behind and (2) 7 mm screws near the floor.
5. Remove lower storage compartment .
6. Remove (2) 7mm screws (facing up) from under cup holder.
7. Remove (3) 7mm hex-head screws and remove radio.
