#### Vehicle Application:

•Nissan Titan 5.5' Bed 2004 – Current Part Number: 16170

•Nissan Titan 6.5' Bed 2004 – Current Part Number: 16175

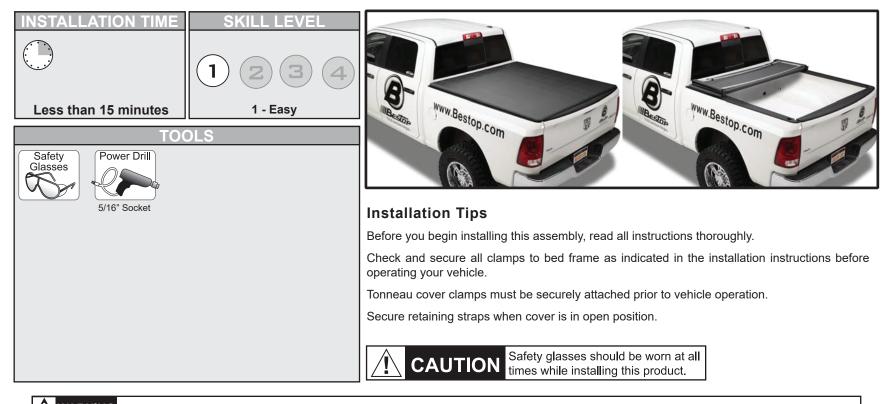
warning The buckle of each retaining strap and both clamps must be fastened securely to avoid damage to personal property or possible personal injury.

If the vehicle has an Over-the-Rail Bedliner, use a certified installer to perform the initial installation. Modifications to the Bedliner may be required.

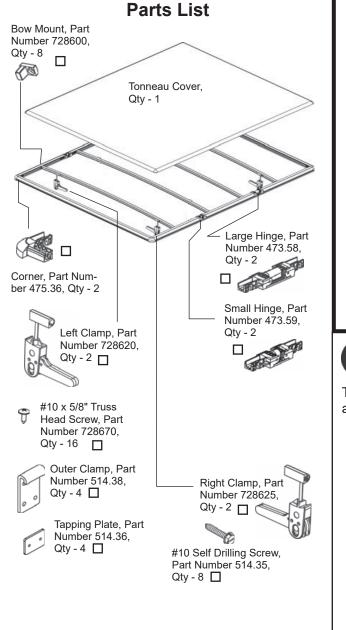
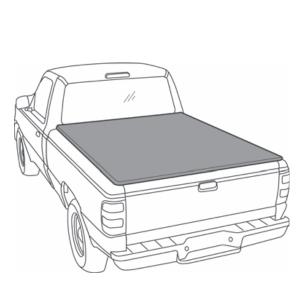
# Remove EZ-Fold Tonneau from Box

Take fully assembled EZ-Fold Tonneau out of box and unfold.

Place the Tonneau on the vehicle with the retaining straps facing up. Align the outside edge of the front rail with the outside edge of the bed. Center the Tonneau from side to side.

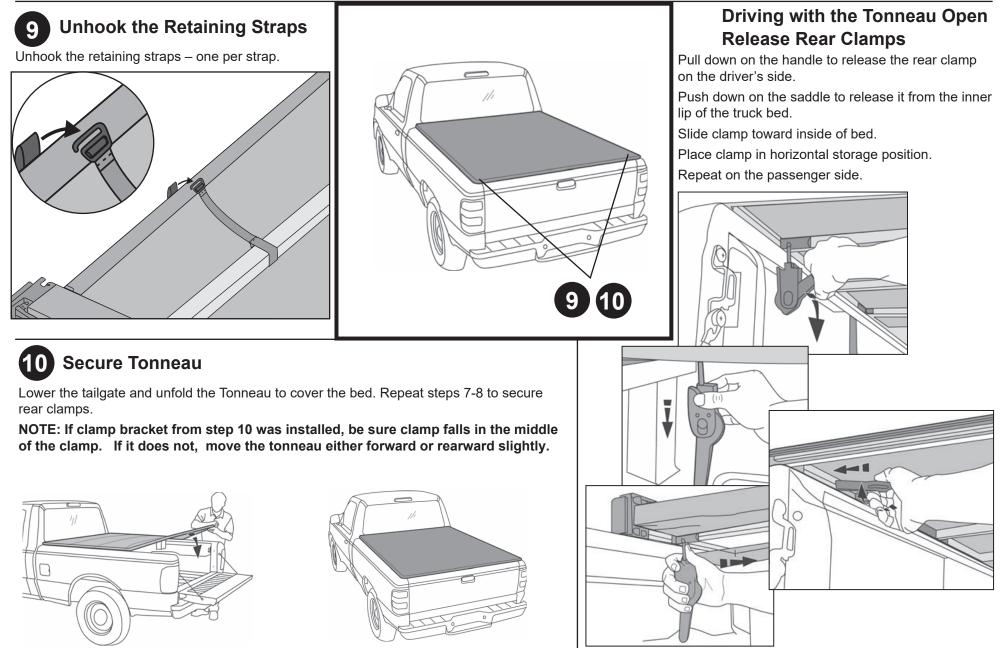
7

Make sure clamps are secure before operating vehicle.

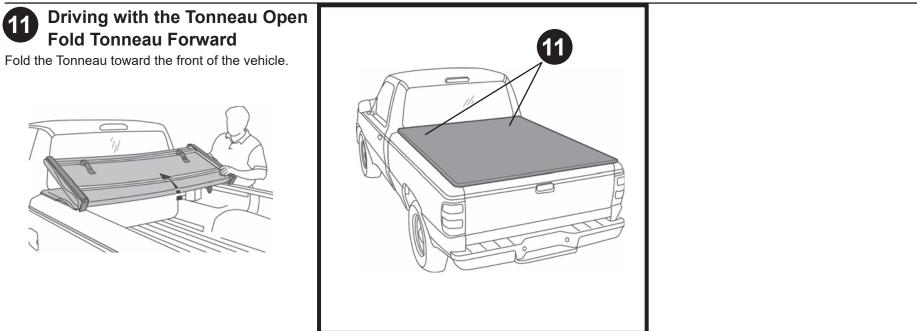
**WARNING** The retaining strap on both sides must be fastened securely to avoid damage to property or possible personal injury.

### Driving with the Tonneau Open Secure Retaining Straps

Hook one of the retaining straps to the front of the Tonneau. (Both sides)
