## Installation Instructions **EZ-Fold Tonneau**

Chevrolet Silverado & **GMC Sierra** 5.8' Beds

Chevrolet Silverado & **GMC Sierra** 6.5' Beds Part Number: 16211

Part Number: 16210

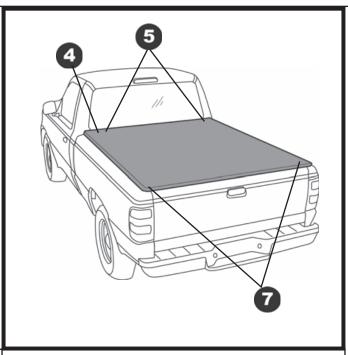
## **Position Front Clamp**

Slide the clamp to the end of the bow. Position the notched section of the saddle under the inner lip of the truck bed.

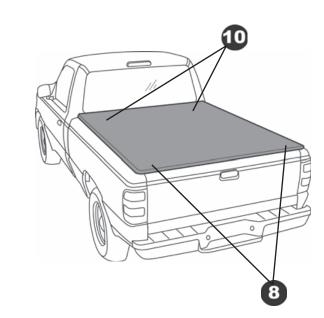
**Driving with the Tonneau Open Release Rear Clamps**

Pull down on the handle to release the rear clamp on the driver's side.

Push down on the saddle to release it from the inner lip of the truck bed.

Slide clamp toward inside of bed.

Place clamp in horizontal storage position.

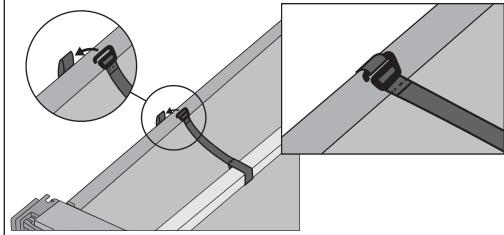
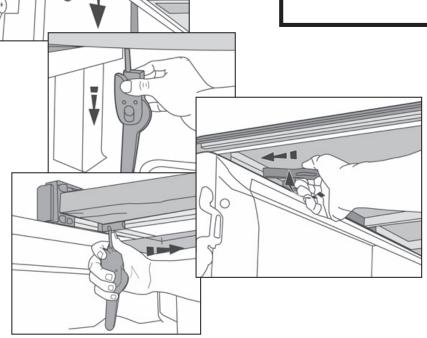
## Driving with the Tonneau Open **Secure Retaining Straps**

Hook one of the retaining straps to the front rail of the Tonneau. (Both sides)

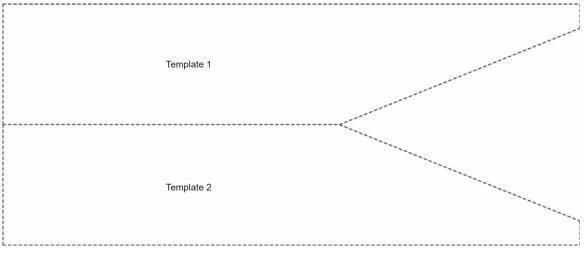
# Place Shims and Corner Pads

Open the rear section of the Tonneau to reveal the rear corner frame. Peel the backing off a Foam Corner Pad and press it into place on the plastic corners. Then install a Foam Shim butted up against the Corner Pad. Repeat on both sides of the vehicle.
