# **EZ-Fold Tonneau**

#### **Vehicle Application:**

• Chevrolet Silverado & GMC Sierra 5.8' Beds Part Number: 16212

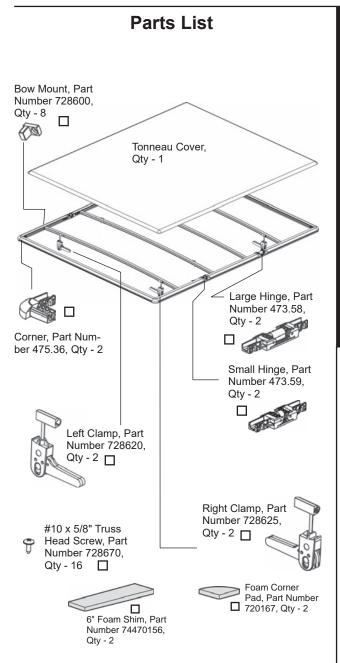
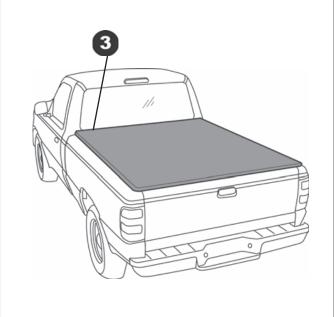
Place the Tonneau on the vehicle with the retaining straps facing up. Align the outside edge of the front rail with the outside edge of the bed. Center the Tonneau from side to side.

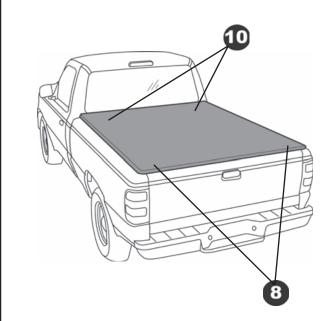
## **Driving with the Tonneau Open Release Rear Clamps**

Pull down on the handle to release the rear clamp on the driver's side.

Push down on the saddle to release it from the inner lip of the truck bed.

Slide clamp toward inside of bed.

Place clamp in horizontal storage position.

Repeat on the passenger side.

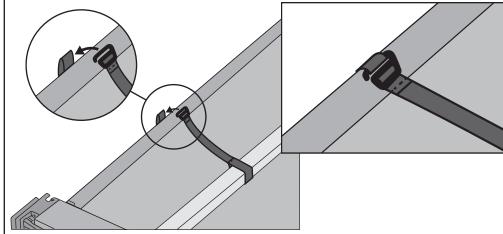
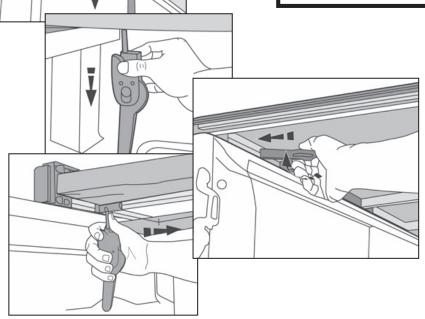
# Driving with the Tonneau Open Secure Retaining Straps

Hook one of the retaining straps to the front rail of the Tonneau. (Both sides)

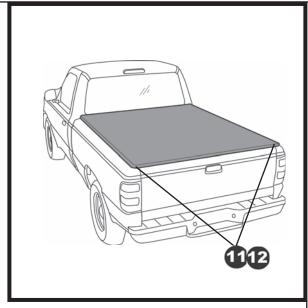
Locate the 6" Foam Shims in the parts kit. Use the template to cut each shim at an angle as shown.

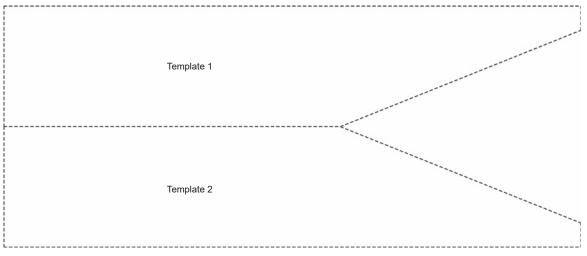
# Place Shims and Corner Pads

Open the rear section of the Tonneau to reveal the rear corner frame. Peel the backing off a Foam Corner Pad and press it into place on the plastic corners. Then install a Foam Shim butted up against the Corner Pad. Repeat on both sides of the vehicle.

-Foam Corner
