• Dodge RAM 2006-2008 1500 6.5' Bed Part Number: 16239

#### **EZ-Fold Tonneau Installation Instructions**

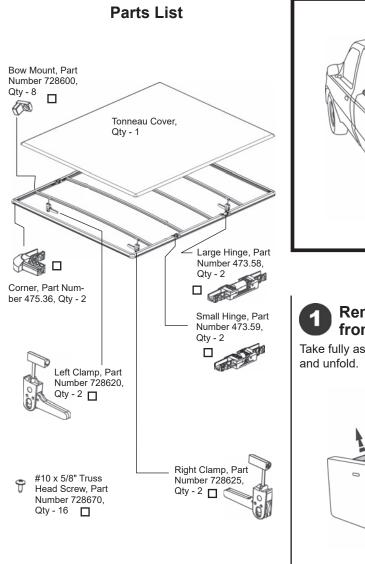
#### **Remove EZ-Fold Tonneau** from Box

Take fully assembled EZ-Fold Tonneau out of box
