• 2009-2024 Ram 1500 Classic

- 5.5' BED
- Part Number: 16241

EZ-Fold Tonneau Installation Instructions

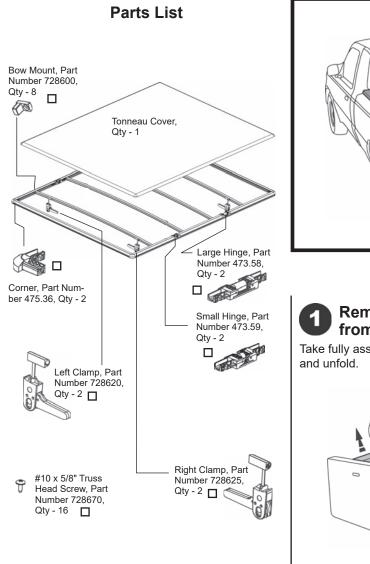
Remove EZ-Fold Tonneau from Box

Take fully assembled EZ-Fold Tonneau out of box

Place Tonneau on Bed 2

Place the Tonneau on the vehicle with the retaining straps facing up. Align the outside edge of the front rail with the outside edge of the bed. Center the Tonneau from side to side.

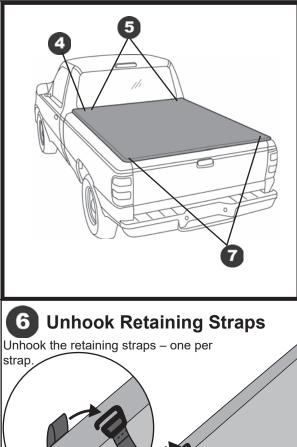
5 Secure Front Clamp

Pull the handle up to secure the clamp.

Repeat Steps 3 - 5 on the passenger side.

Make sure clamps are secure before operating vehicle.

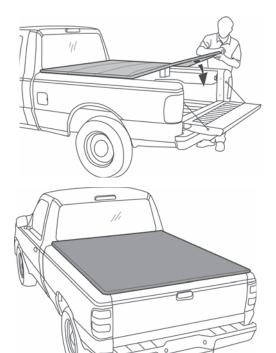
7

Secure Tonneau

Lower the tailgate and unfold the Tonneau to cover the bed.

Repeat Steps 3 - 5 to secure the rear clamps on both sides of the vehicle.
