#### Vehicle Application:

• Nissan Frontier | E ' bed • 2005 - Current Part Number: 1914Î

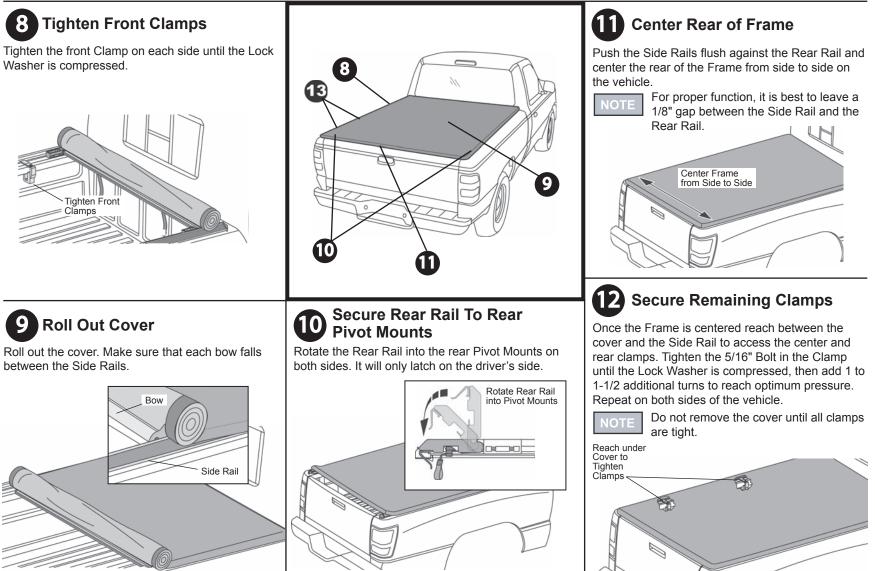
Center Frame from Side to Side
