Vehicle Application:

BlqqUb'HlHUb 5.5' bed 04-Current Part Number: 19175

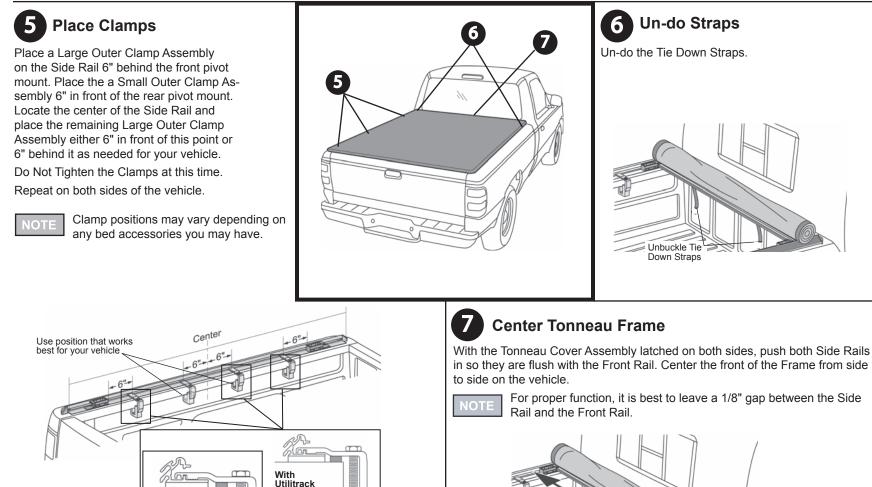
Use the 5/16" Bolts to assemble the Large and Small Outer Clamps to the Inner Clamps. Create six (6) Clamp Assemblies.

#### **3** Secure Tonneau Cover Assembly to Passenger Side Rail

Place the Tonneau Cover Assembly into the front pivot on the Passenger Side Rail. Engage the cover assembly latch into the slot on the Side Rail. Make sure that the cover assembly is flush against the Side Rail.

Place Side Rails on Bed

Locate the 2 side rails. Remove the protective tape on the bottom of each rail and place the rail on the bed on each side of the vehicle.

Once the rails are on the bed, align the front edge of each Side Rail, with the inside edge of the front bulkhead.

# Secure Driver Side Rail to Tonneau Cover Assembly

Place the Driver's Side Rail into the Tonneau Cover Assembly. Make sure the cover assembly latch is fully engaged into the slot on the Side Rail and that the cover assembly is flush against the Side Rail.

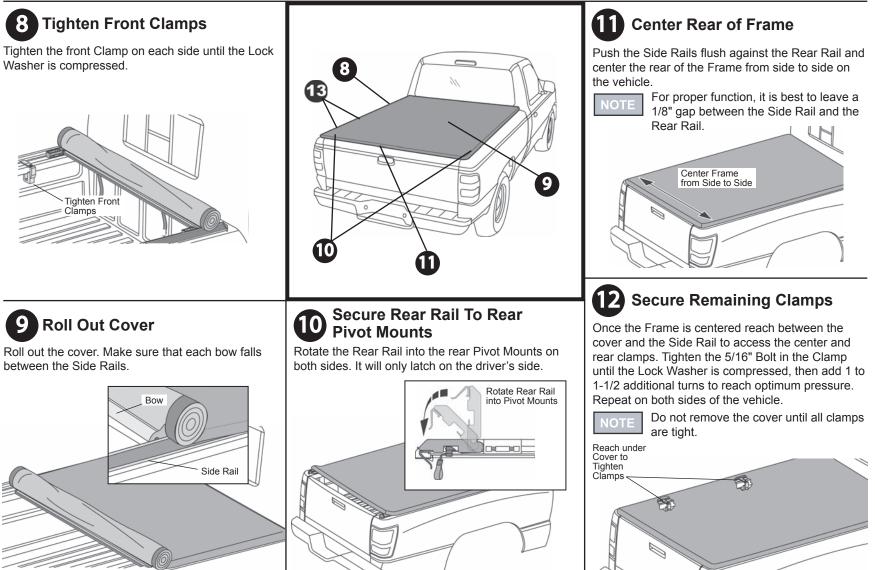
Center Frame from Side to Side

System

Without Utilitrack
