Vehicle Application:

HcmcHJTundra 5.5' bed 07 to Current Part Number: 19182

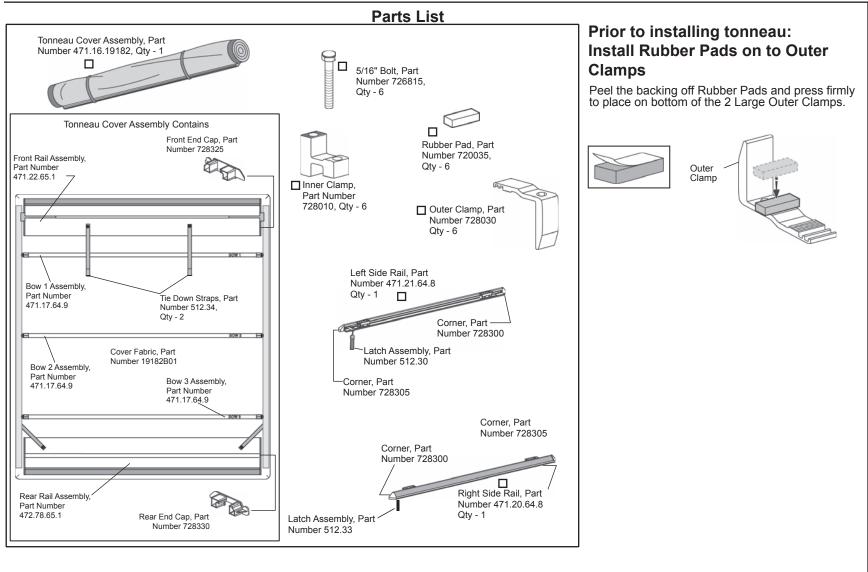
Assemble Clamps

Use a 5/16" Bolt to secure an Outer Clamp to an Inner Clamp. Repeat on all Clamp assemblies

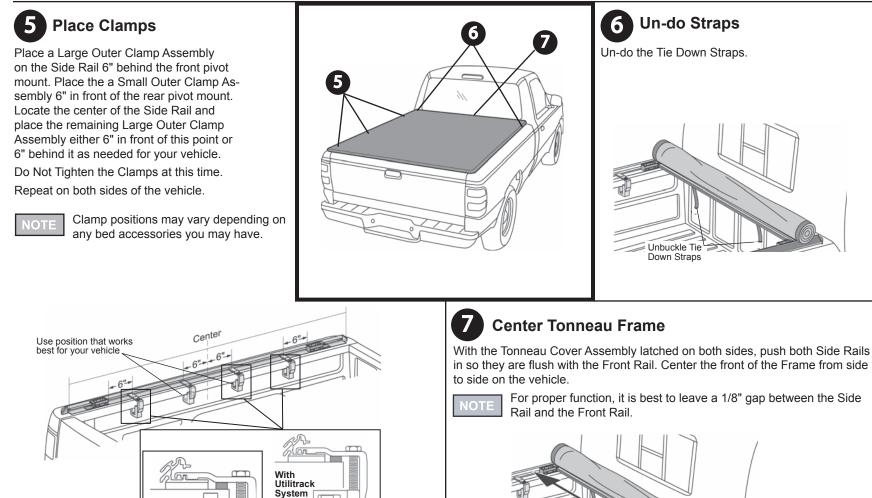
Without Utilitrack

System

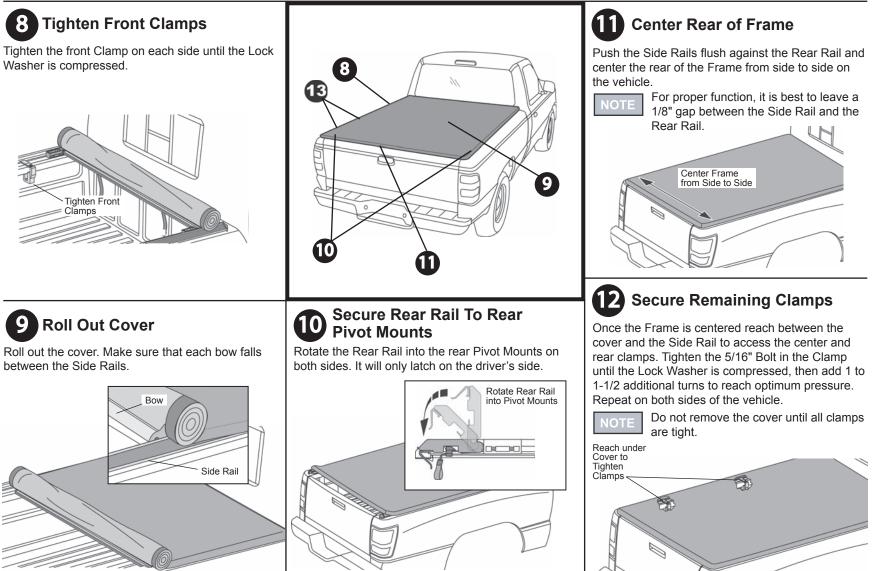
Center Frame from Side to Side
