• Chevrolet GI j YfUXc/GMC GIYffU 6.5' bed 1999 - 2007 Part Number: 19205

3 Secure Tonneau Cover Assembly to Passenger Side Rail

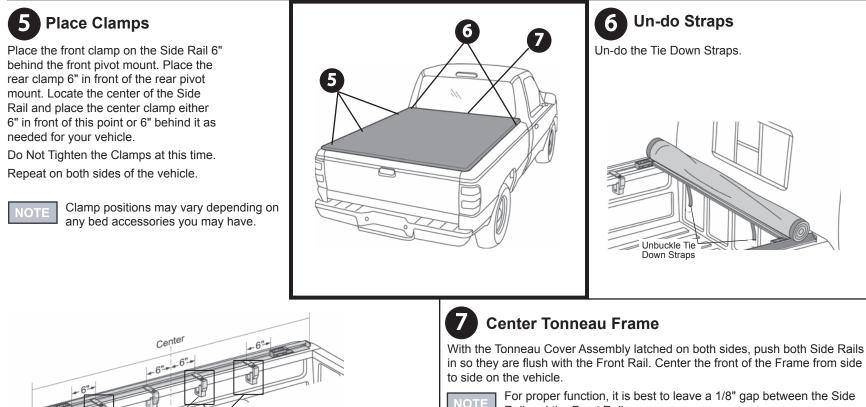
Place the Tonneau Cover Assembly into the front pivot on the Passenger Side Rail. Engage the cover assembly latch into the slot on the Side Rail. Make sure that the cover assembly is flush against the Side Rail.

Place the Driver's Side Rail into the Tonneau Cover Assembly. Make sure the cover assembly latch is fully engaged into the slot on the Side Rail and that the cover assembly is flush against the Side Rail.
