### **Vehicle Application:**

Chevrolet Silverado / Sierra

6.5' Bed

Part Number: 19211

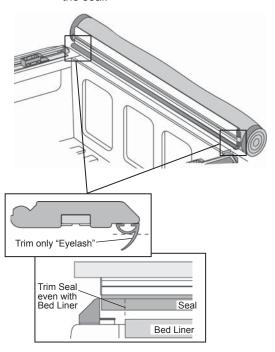
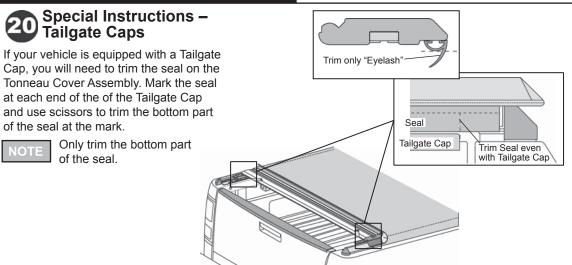
### Special Instructions – **Bed Liners**

If your vehicle is equipped with a Bed Liner that comes up over the front bulkhead, you will need to trim the seal on the Tonneau Cover Assembly. Mark the seal at each end of the of the Bed Liner and use scissors to trim the bottom, "eyelash", part of the seal at the mark.

Only trim the bottom, "eyelash", part of the seal.
