Vehicle Application:

• RAM 8' bed

2019-Current

• Part Number: 19229

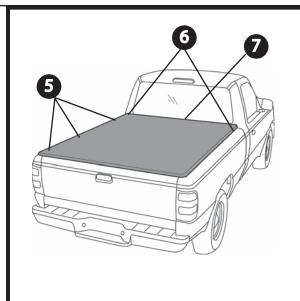
Place the Large front clamp on the Side Rail 6" behind the front pivot mount. Place the medium rear clamp 6" in front of the rear pivot mount. Locate the center of the Side Rail and place a Large center clamp either 6" in front of this point or 6" behind it as needed for your vehicle.

Do Not Tighten the Clamps at this time. Repeat on both sides of the vehicle.

Clamp positions may vary depending on any bed accessories you may have.

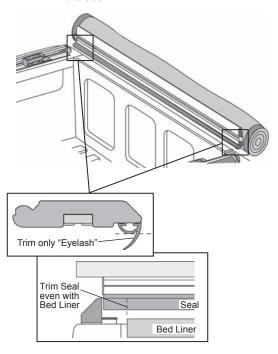
If your vehicle is equipped with a Bed Liner that comes up over the front bulkhead, you will need to trim the seal on the Tonneau Cover Assembly. Mark the seal at each end of the of the Bed Liner and use scissors to trim the bottom, "eyelash", part of the seal at the mark.

Only trim the bottom, "eyelash", part of the seal.
