Vehicle Application:

- Ford Ranger 6' bed
- 19-Current
- Part Number 19233

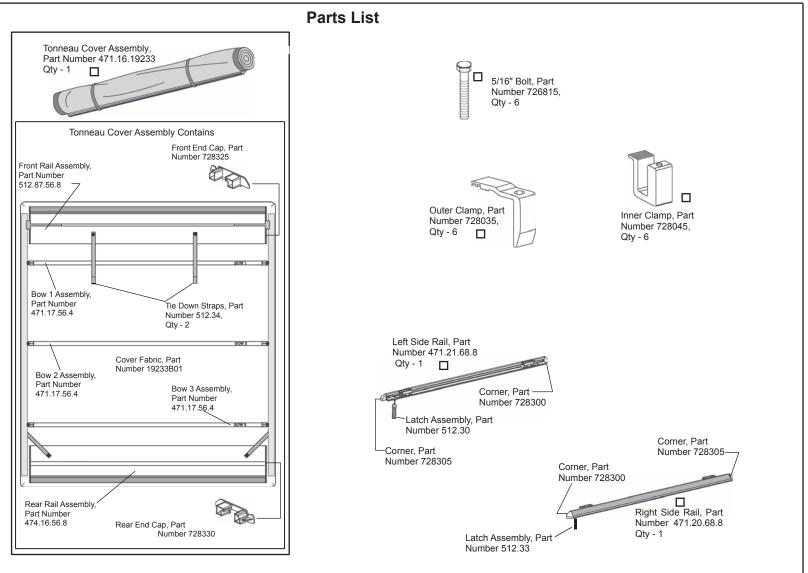
5/16" Bolt

Assemble Clamps

Use a 5/16" Bolt to secure an Outer Clamp to an Inner Clamp. Repeat for six (6) assemblies.

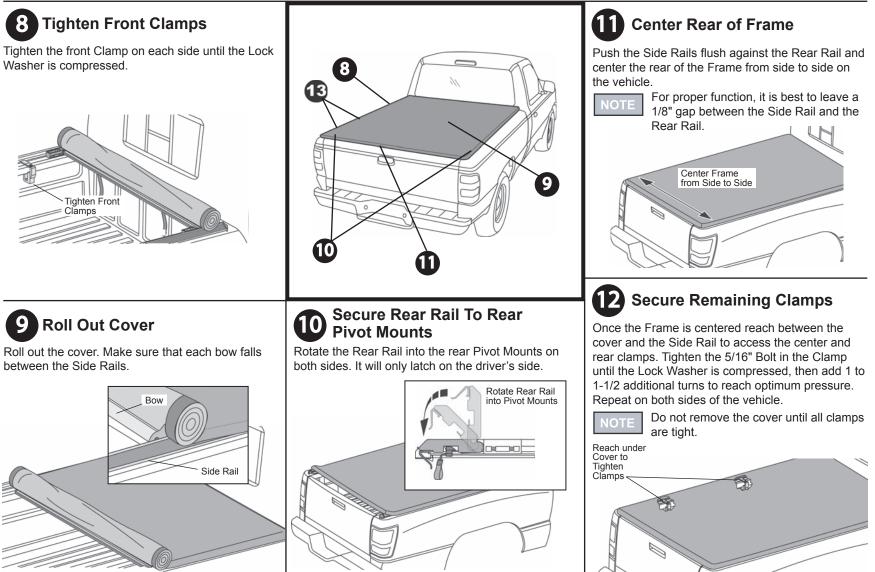
in so they are flush with the Front Rail. Center the front of the Frame from side

Rail and the Front Rail.
